# **Ammonoosuc River Geomorphic Assessment, Floodplain Conservation, and River Corridor Planning**

Connecticut River Joint Commissions  
Lebanon, NH

Dr. John Field  
Field Geology Services  
Farmington, ME

October 2011

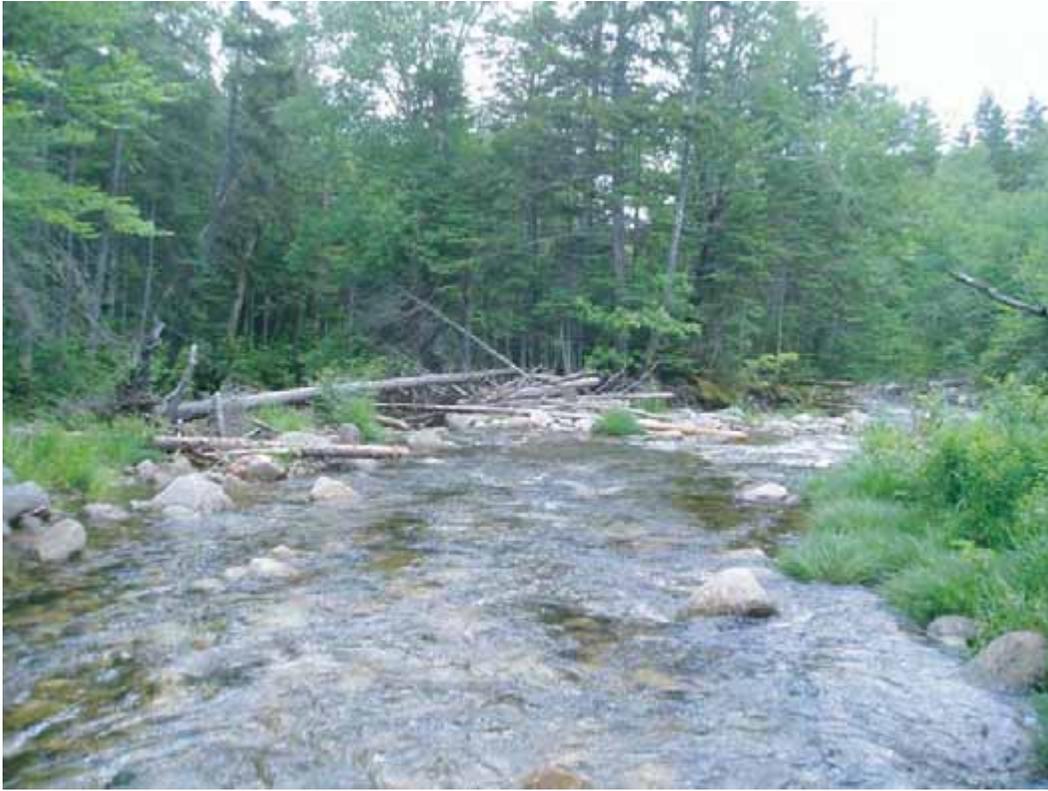
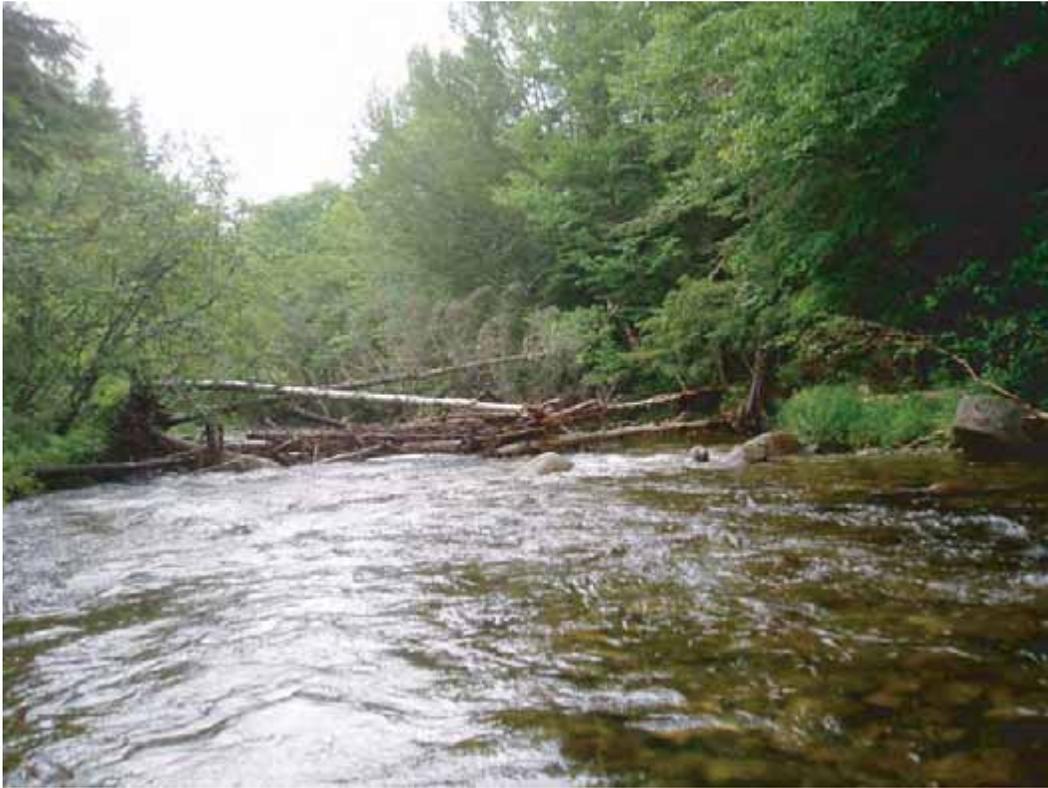
Figure 5. Log jams in the headwaters of the Ammonoosuc River are responsible for frequent channel avulsions between different threads of the anastomosed channels.

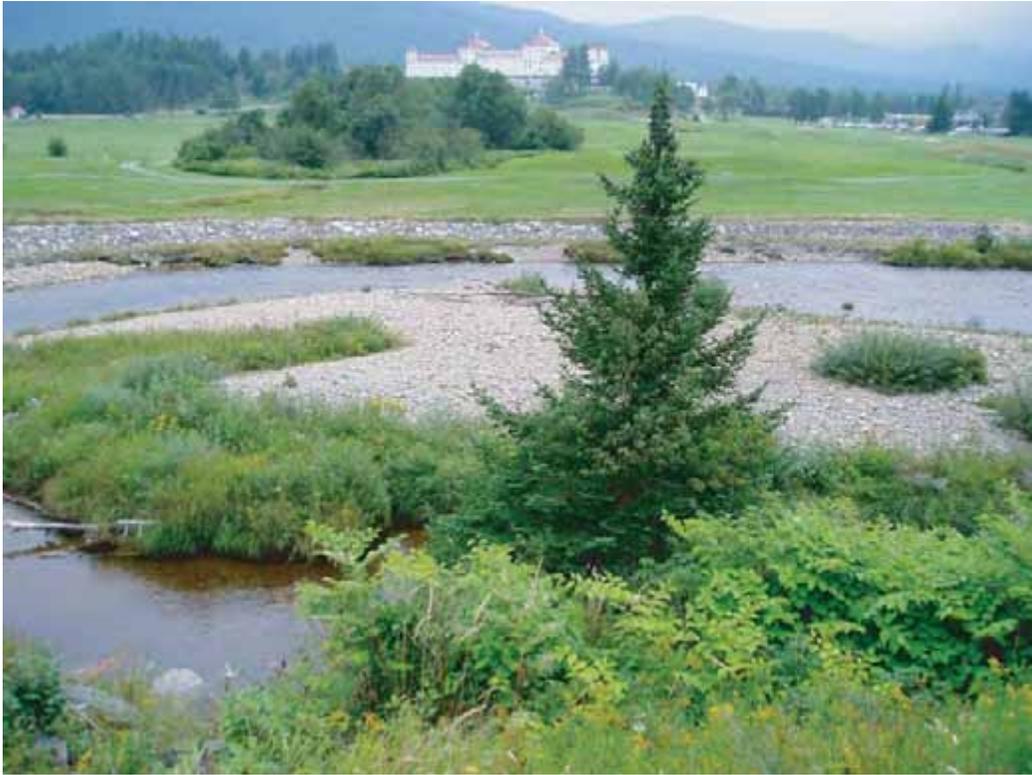
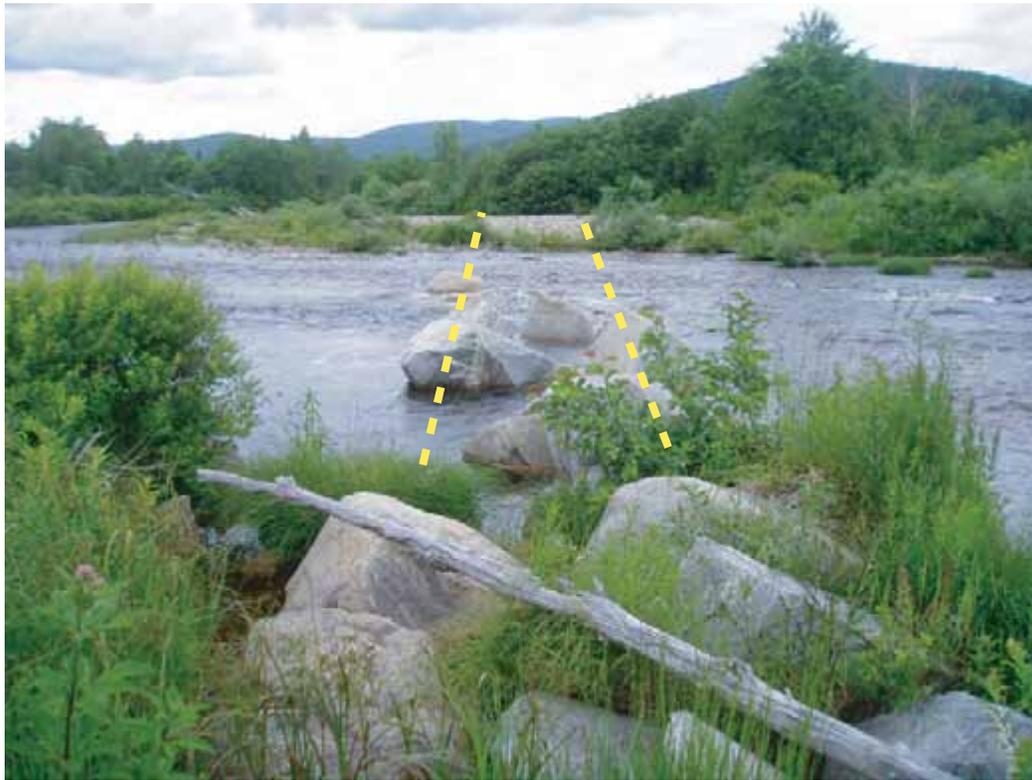
Figure 7. a) Large unvegetated gravel bars and b) the resulting channel migration characterize the Bretton Woods area. Channel migration in “b” is evidenced by river now flowing over previous bank stabilization efforts.

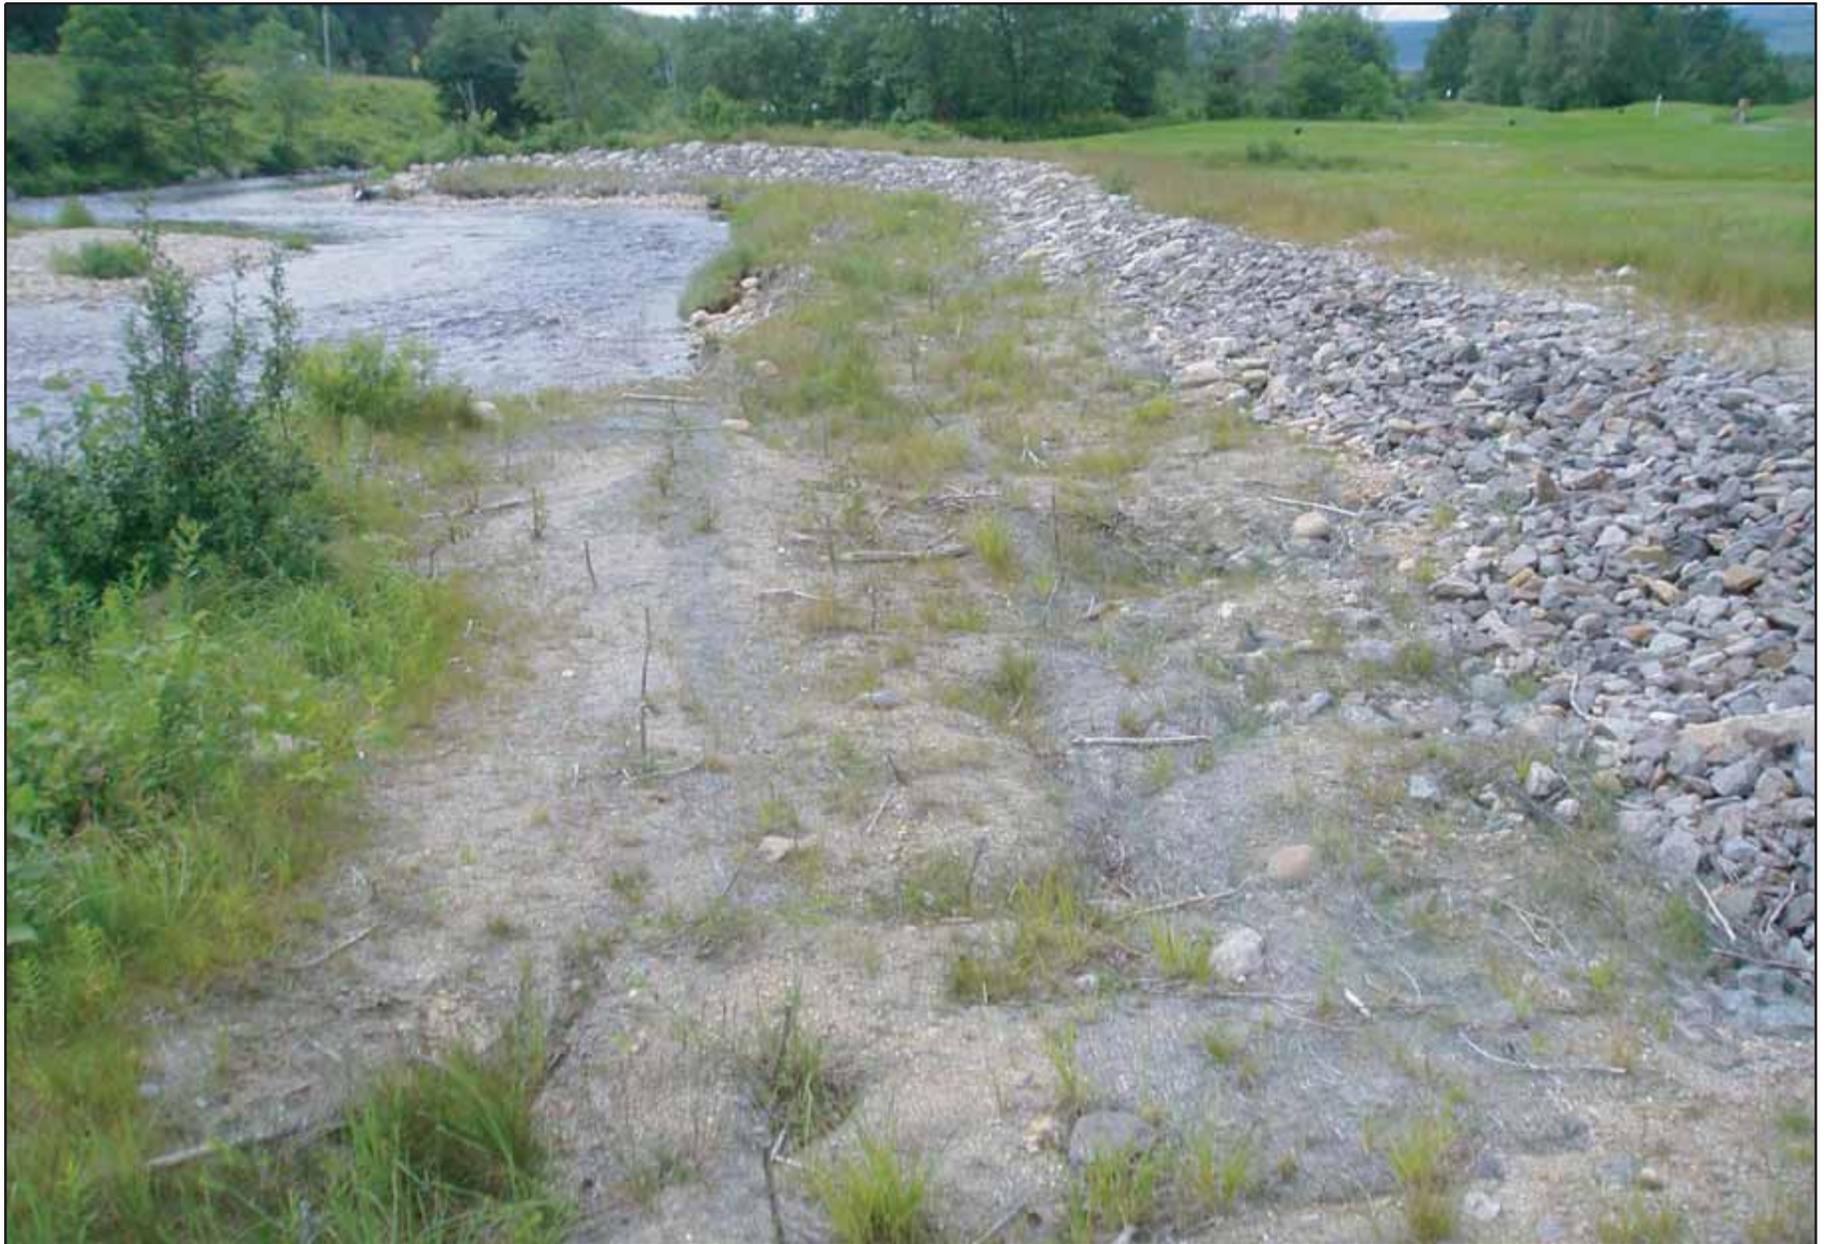
Figure 8. Recent bank stabilization project incorporating a floodplain bench in front of the eroding bank to reduce erosive forces through flow attenuation.

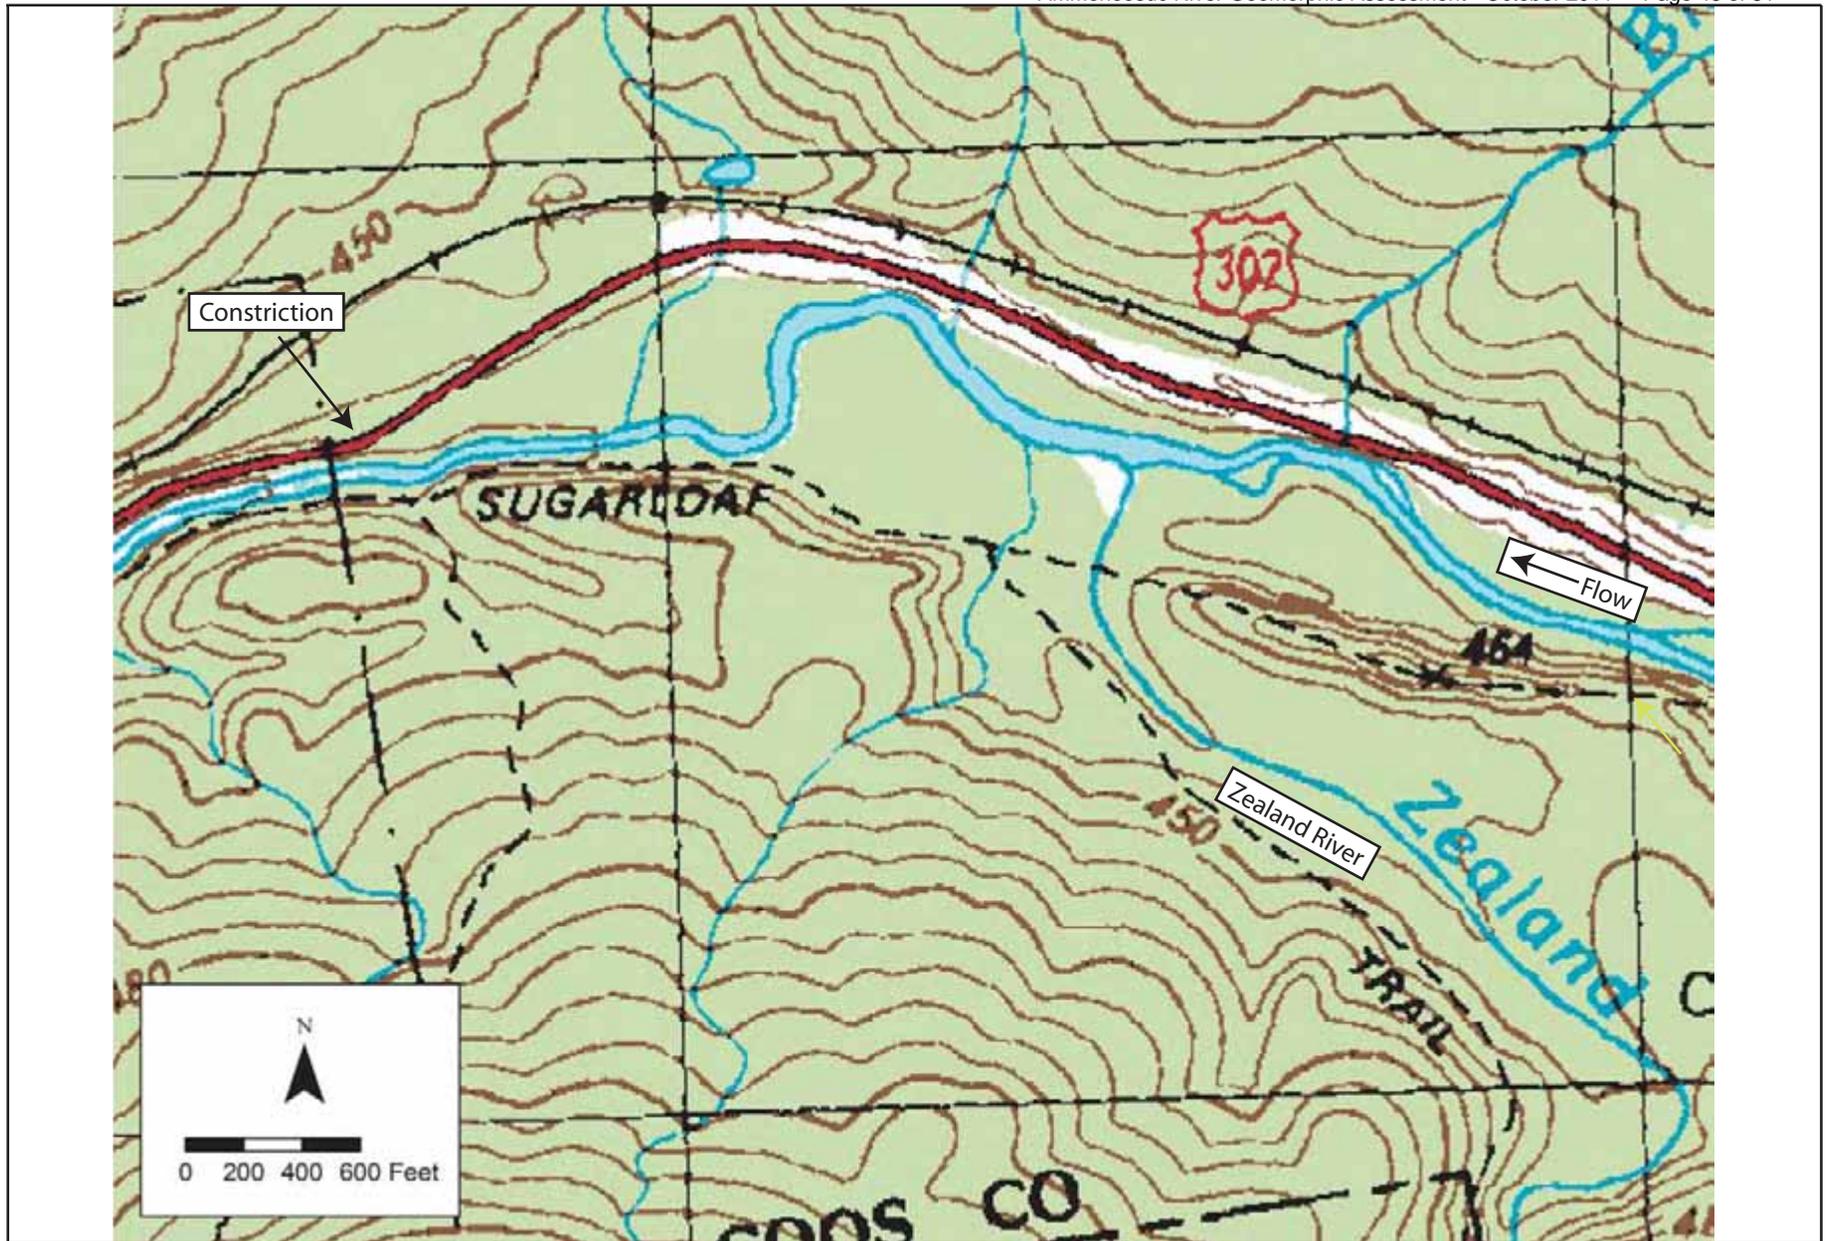
Figure 10. Sediment inputs from the Zealand River cause extensive bar formation and channel migration on the Ammonoosuc River, a situation enhanced by a downstream valley constriction

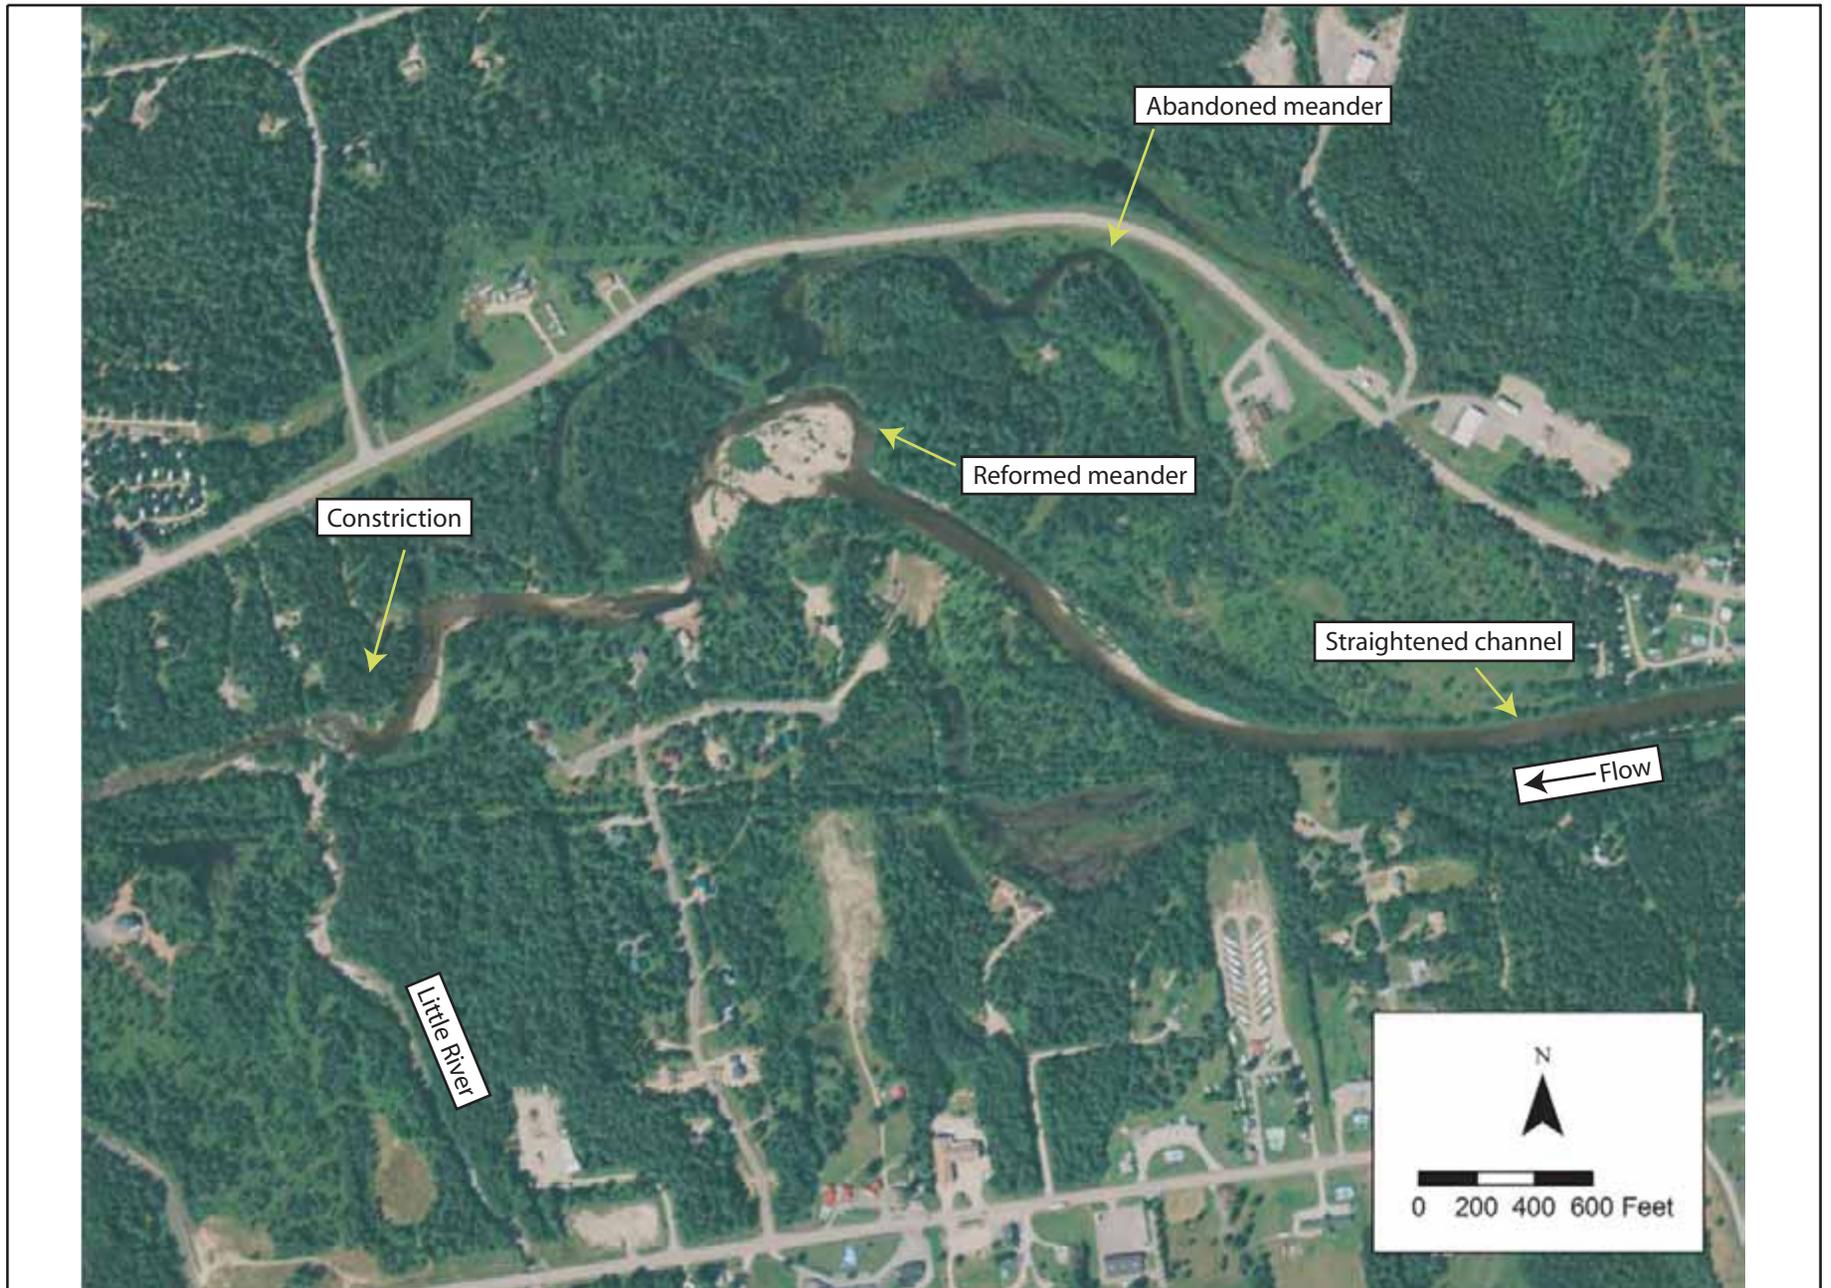
Figure 11. Sediment inputs from the Little River confluence occur at a natural valley constriction and enhance the upstream deposition responsible for channel migration and the reforming of meanders along the formerly straightened channel.

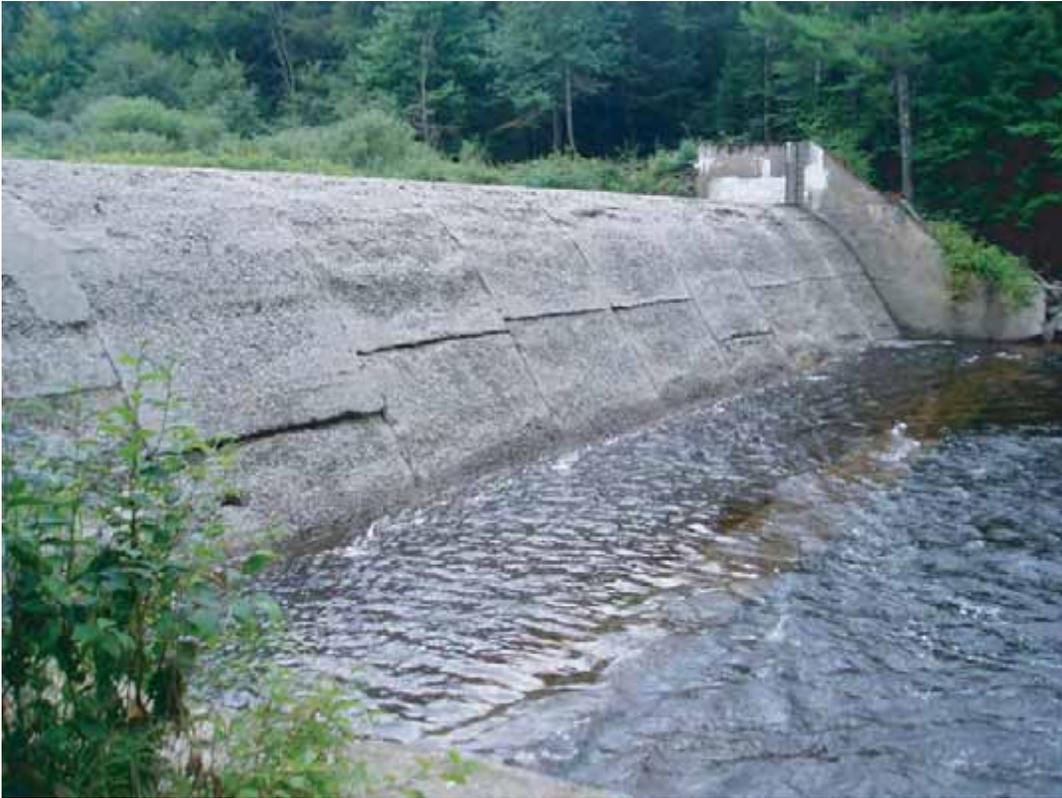
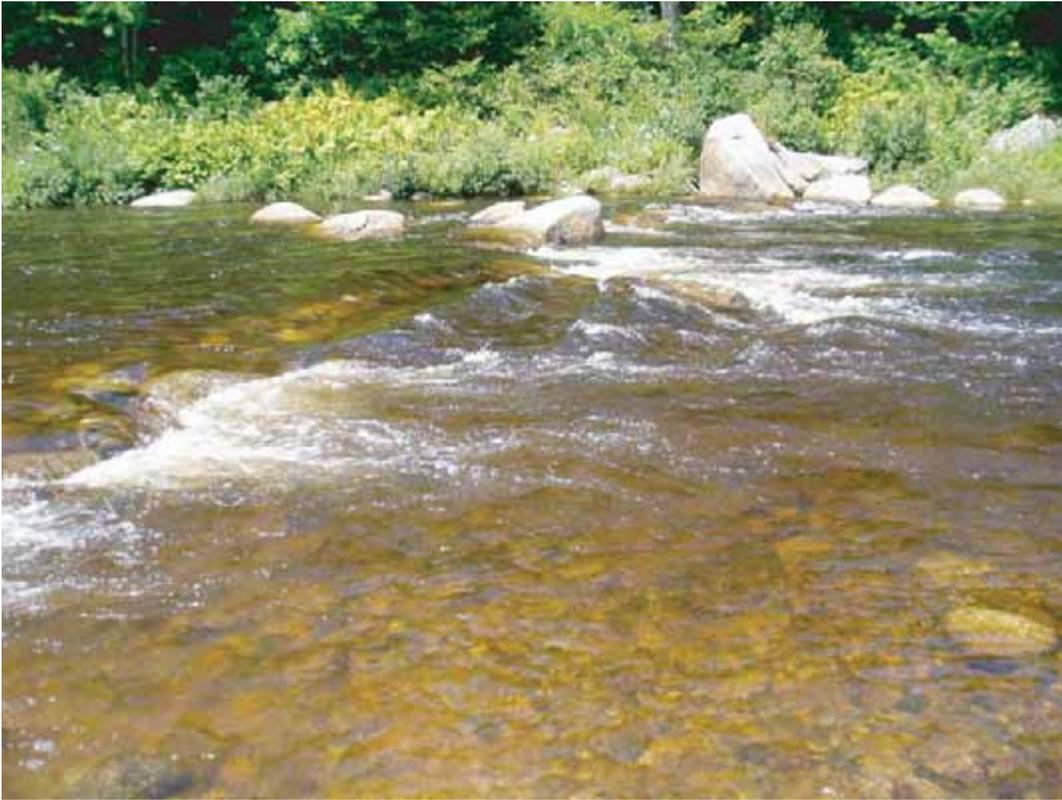
Figure 12. Decommissioning and lowering of the impoundment level upstream of a) the Bethlehem Dam has b) led to upstream migration of a headcut that has incised through a portion of the impoundment sediments.

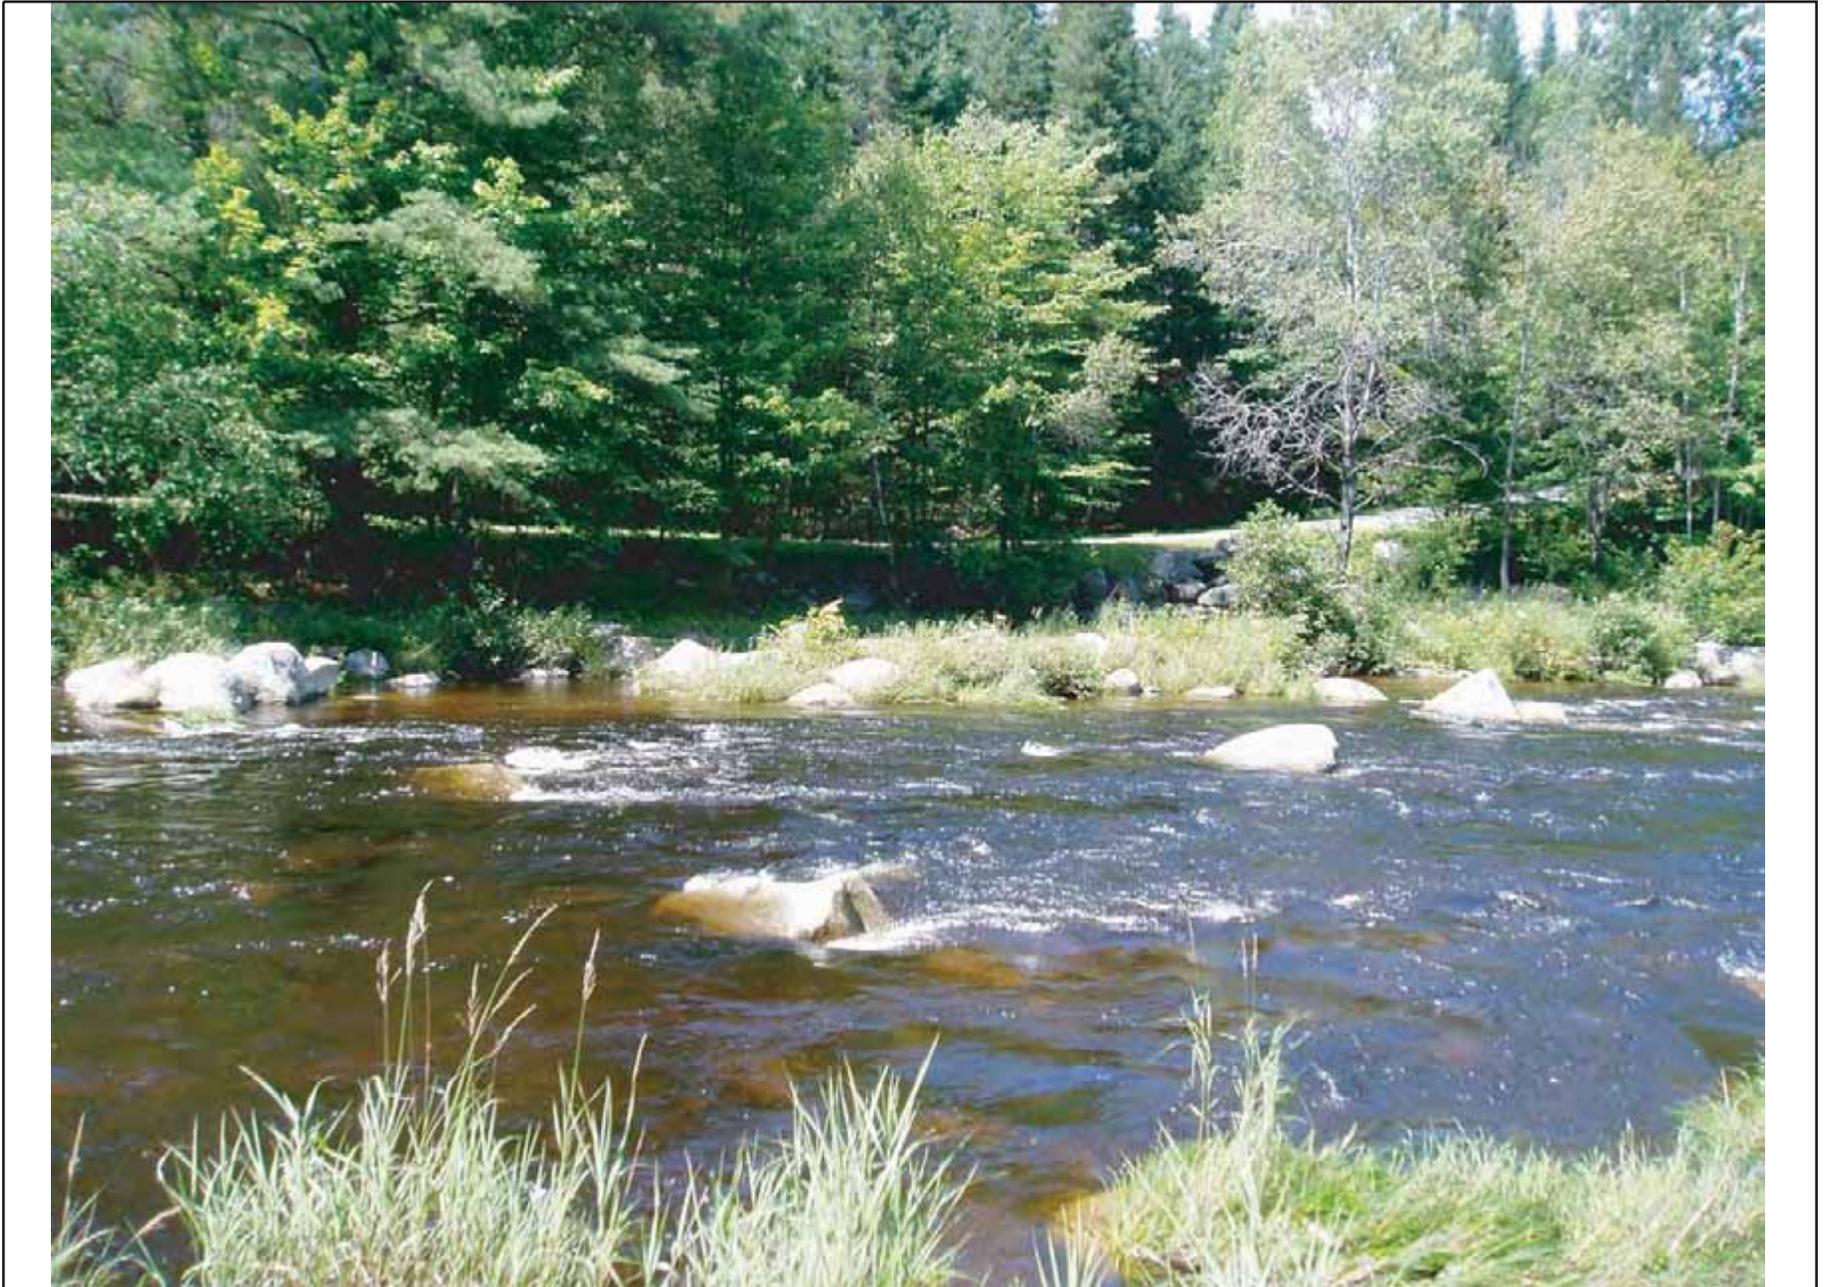
Figure 13. A considerable length of the channel in Bethlehem Hollow is armored against erosion due to the steep gradient and valley confinement.

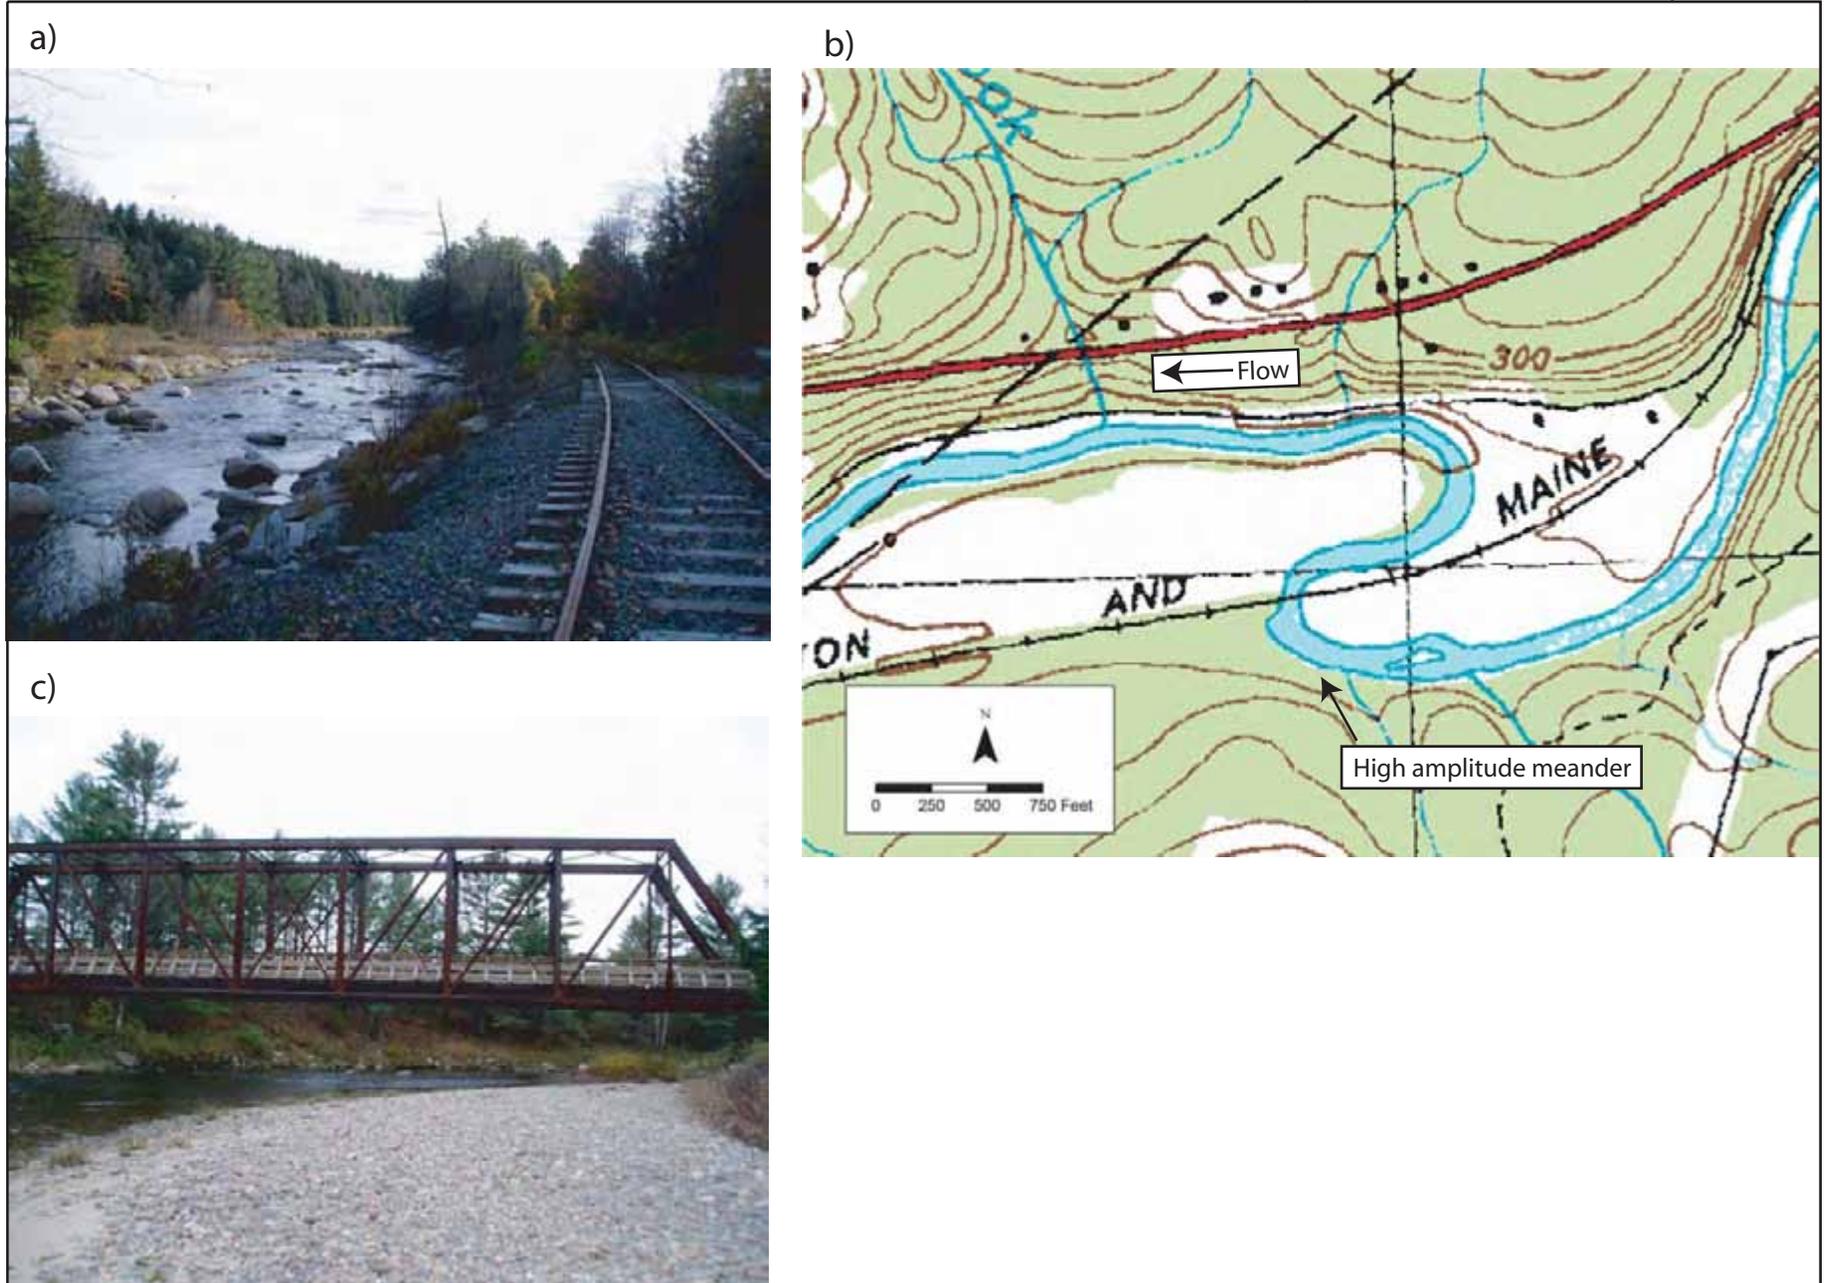
Figure 14. The railroad grade in the lower Bethlehem section a) blocks floodplain access, causing b) the growth of high amplitude meanders and c) considerable upstream sediment deposition.

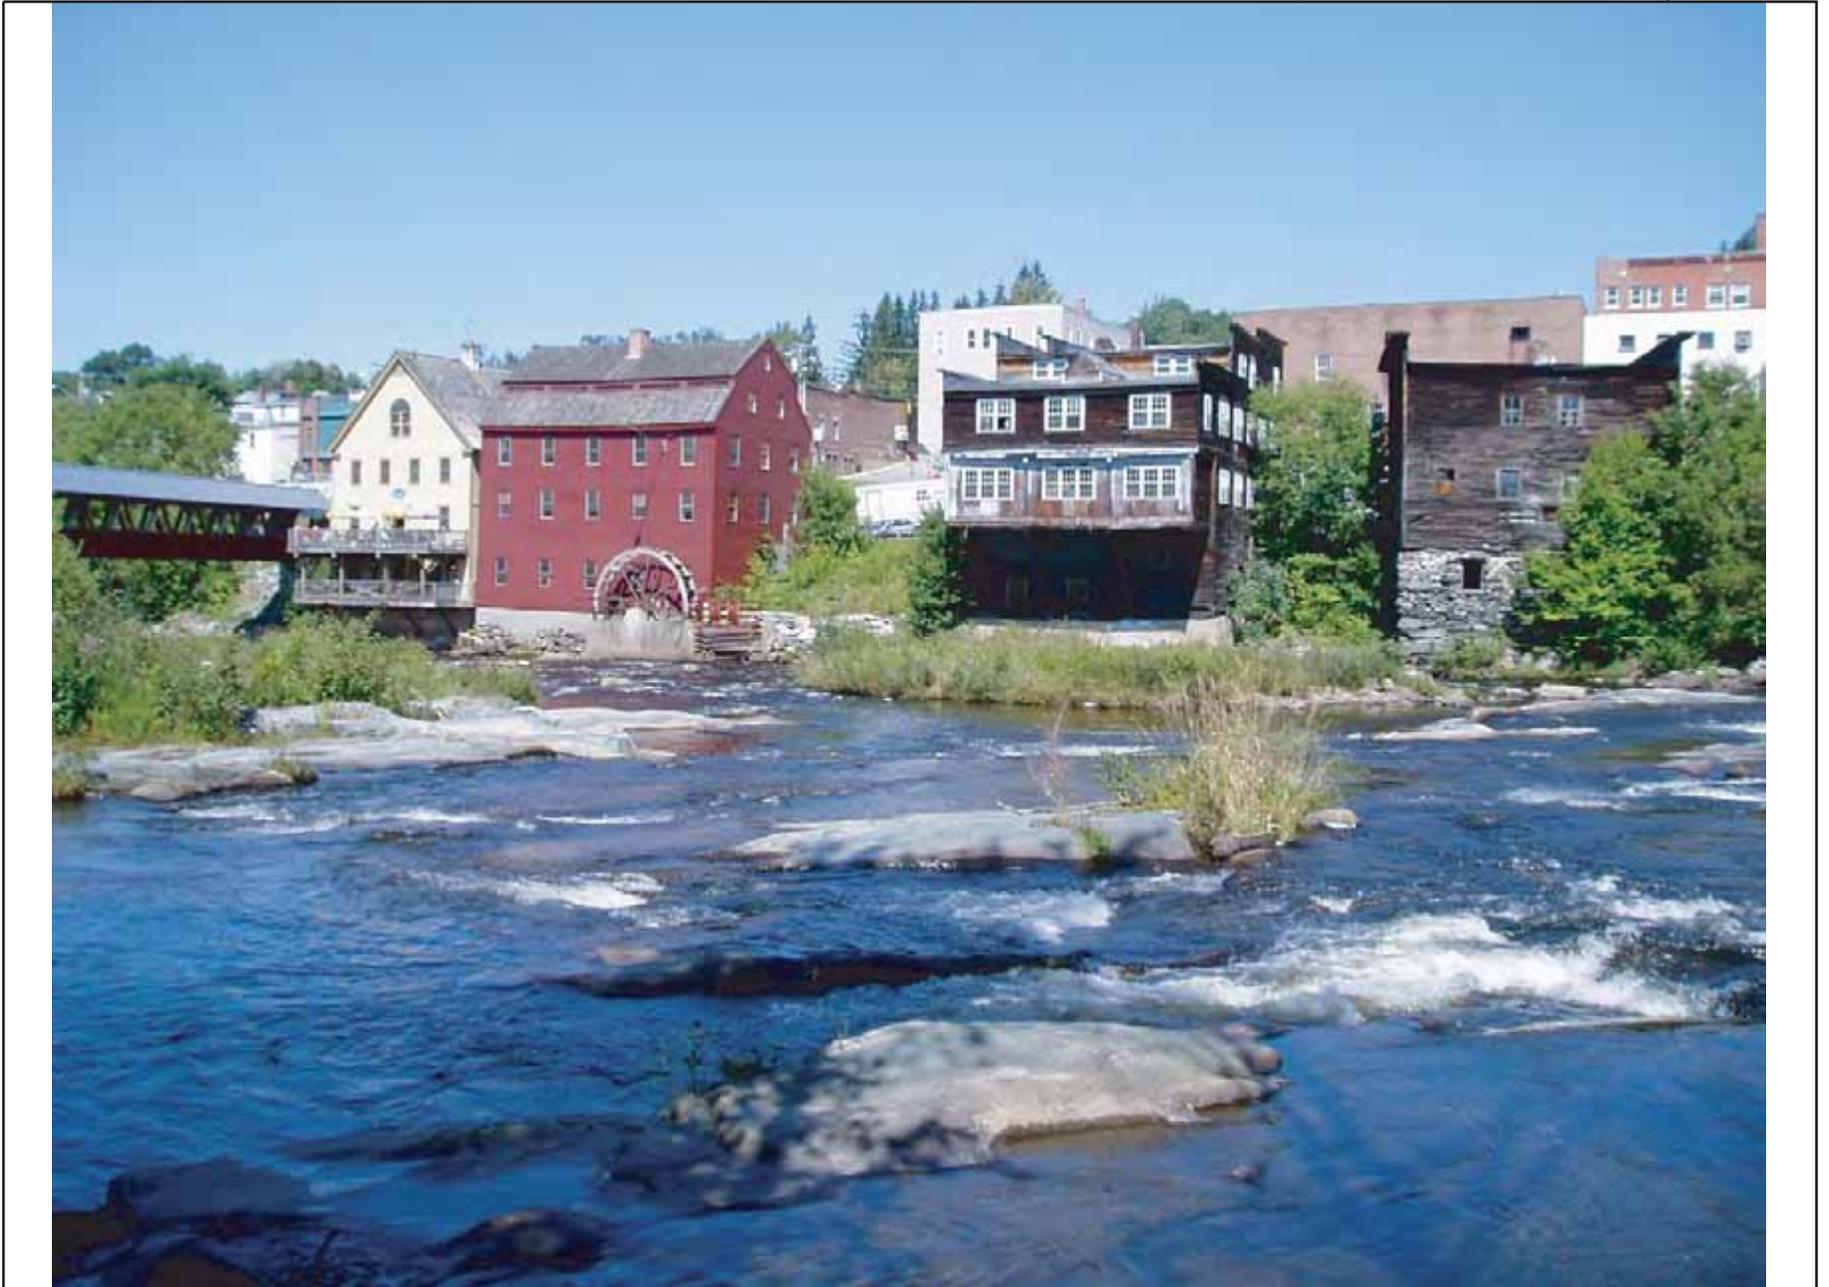
Figure 15. Bank armoring is significant through the Littleton Village section.

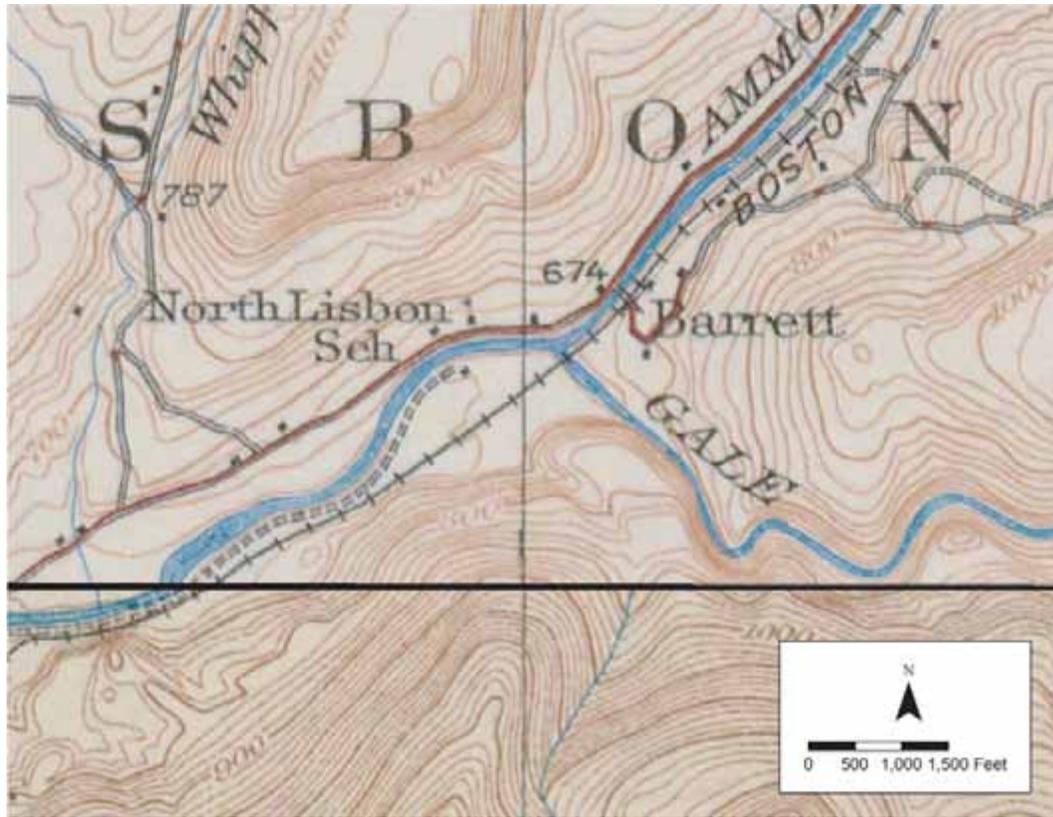
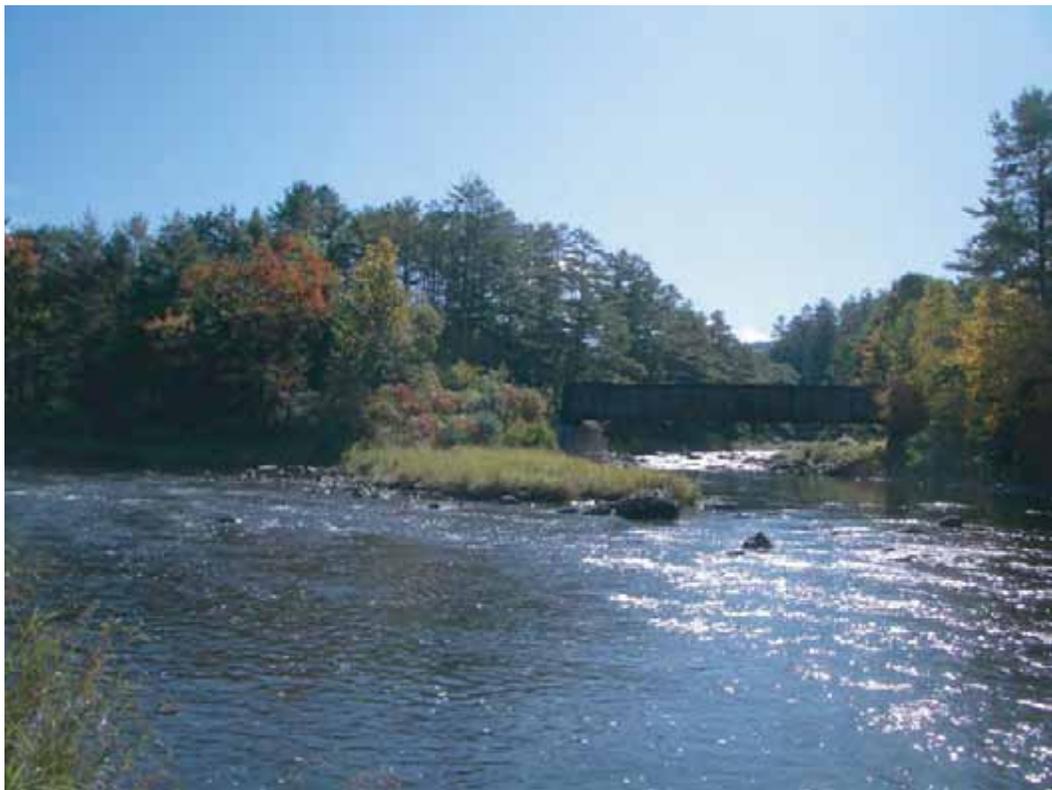
Figure 18. a) Past channel straightening of the lower Gale River has led to b) the formation of a large delta bar at the confluence with the Ammonoosuc River.

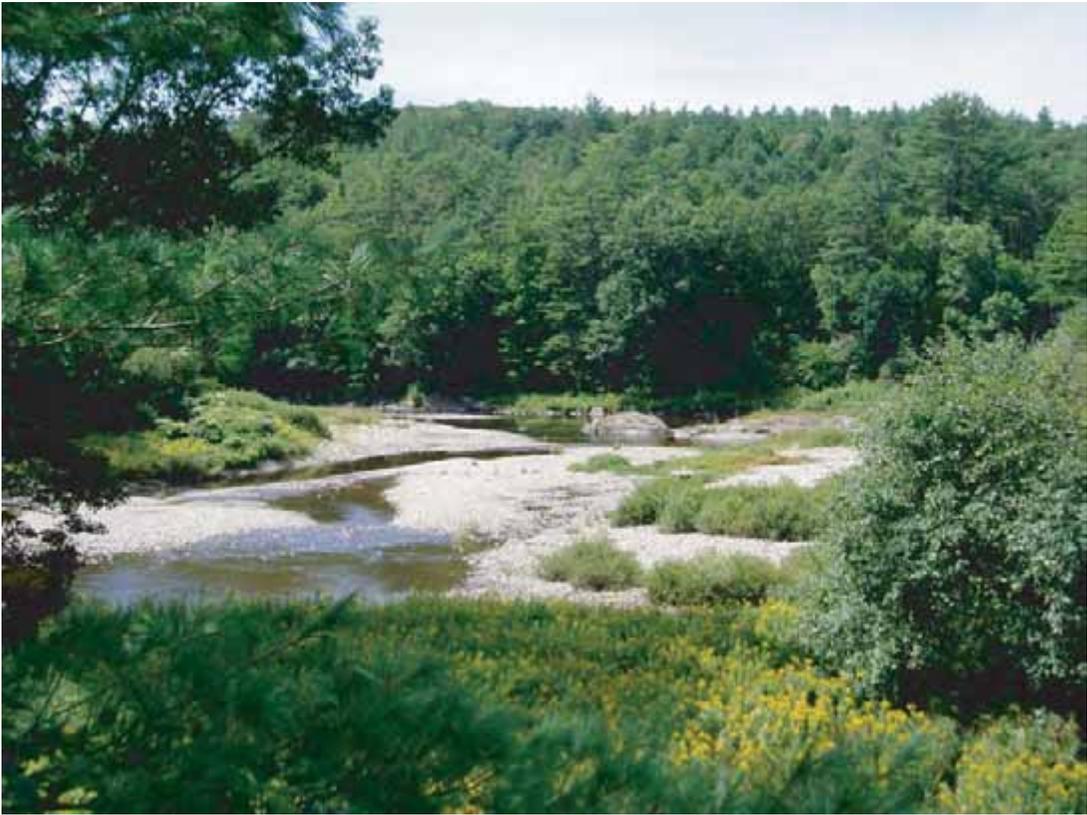
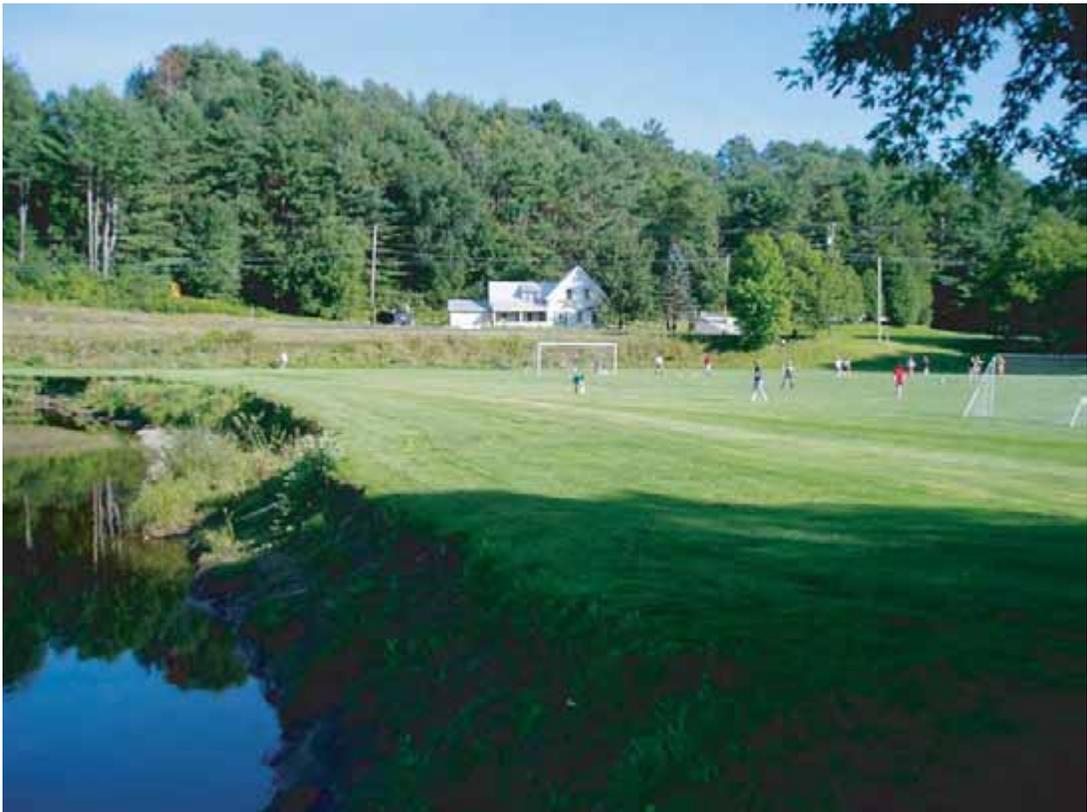
Figure 20. High sediment supply from Salmon Hole is resulting in the formation of a) large unvegetated gravel bars that, in turn, divert flow and cause b) erosion of the adjacent banks such as at the practice soccer field in Lisbon.
