# **Ammonoosuc River Geomorphic Assessment, Floodplain Conservation, and River Corridor Planning**

Connecticut River Joint Commissions  
Lebanon, NH

Dr. John Field  
Field Geology Services  
Farmington, ME

October 2011

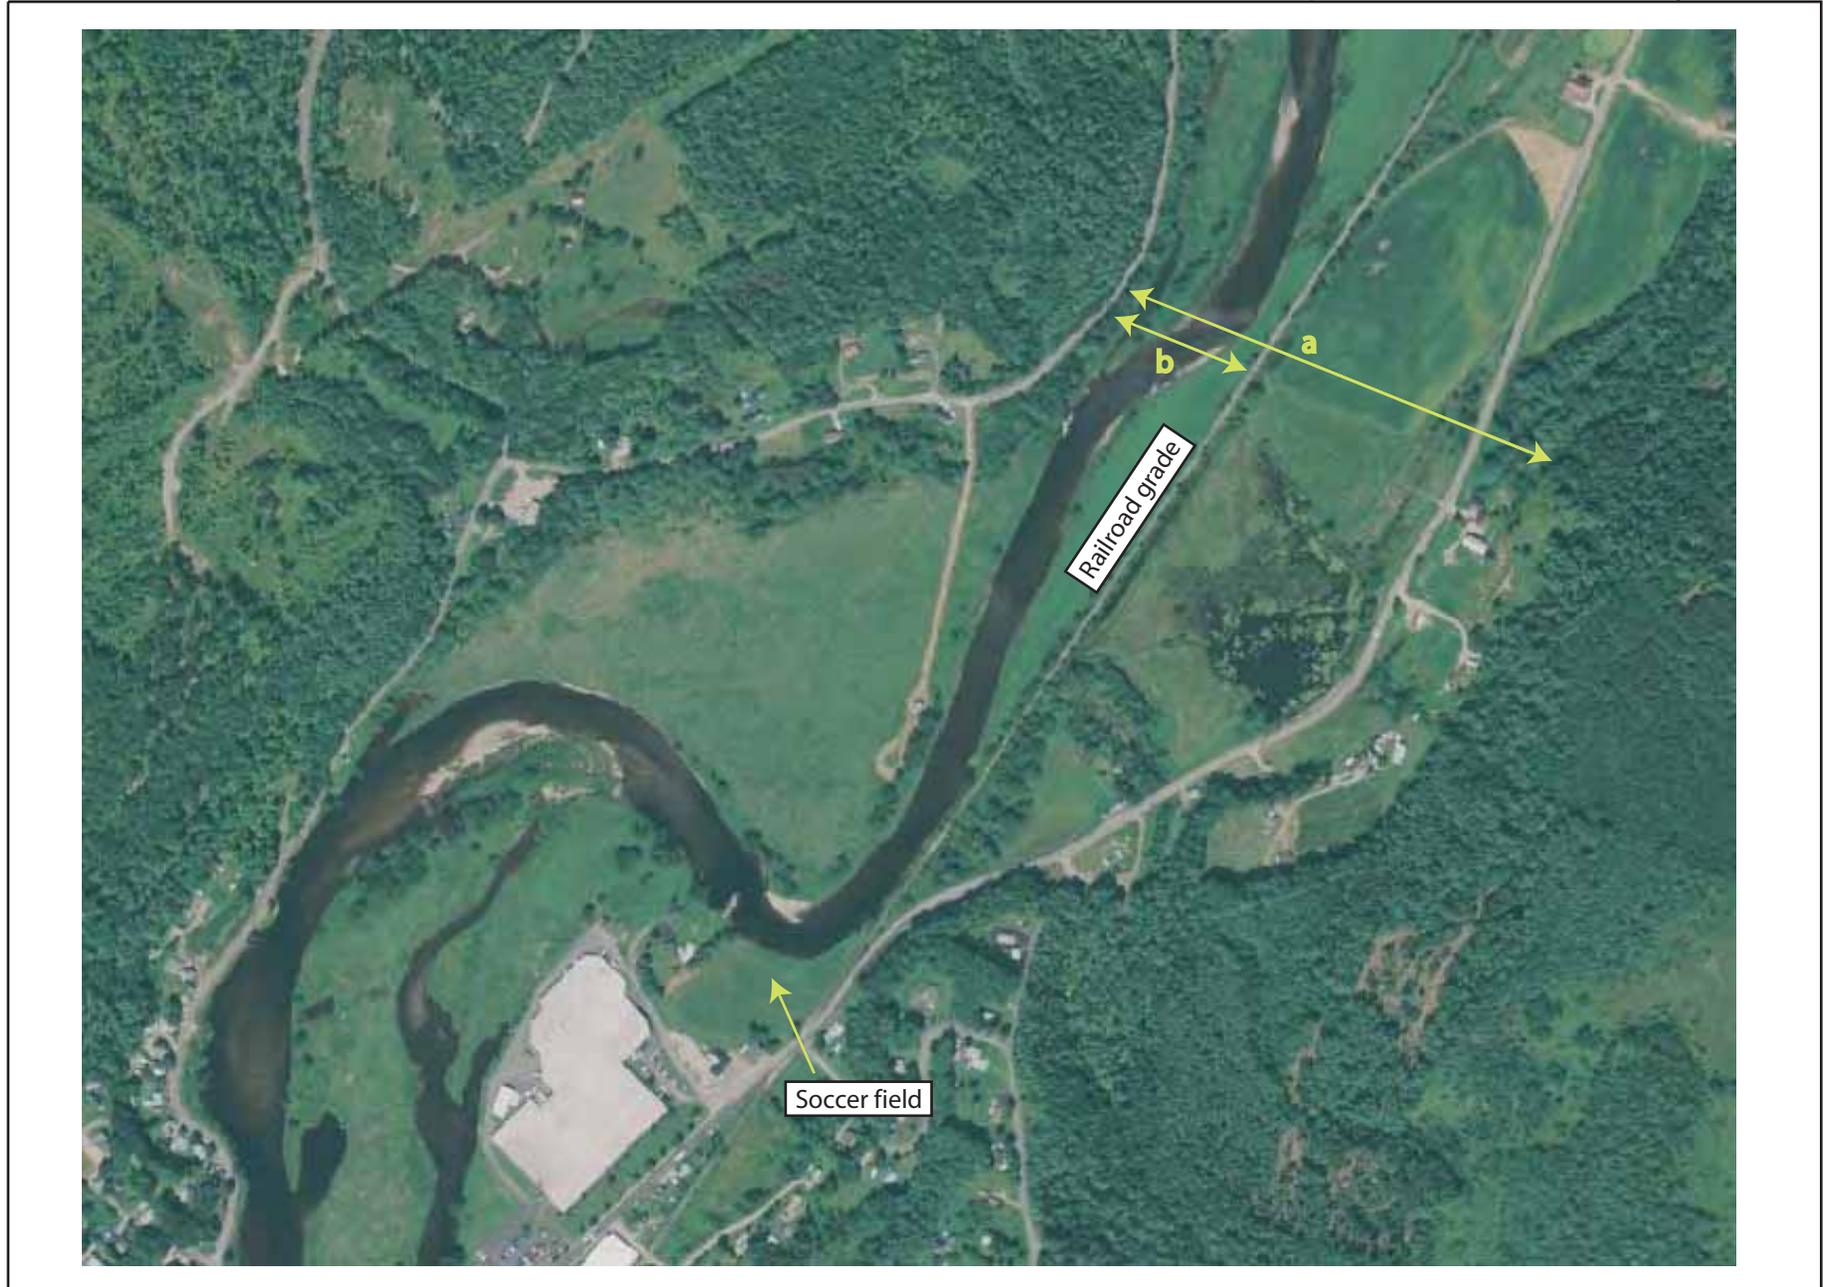
Figure 21. The eroding bank at the practice soccer field in Lisbon (see Figure 20b) is at the end of a long artificially straightened section of the channel. Note railroad grade is blocking the river's access to a large portion of its natural floodplain (arrow a), reducing the space that the river currently has to spread out at high flow stages (arrow b).

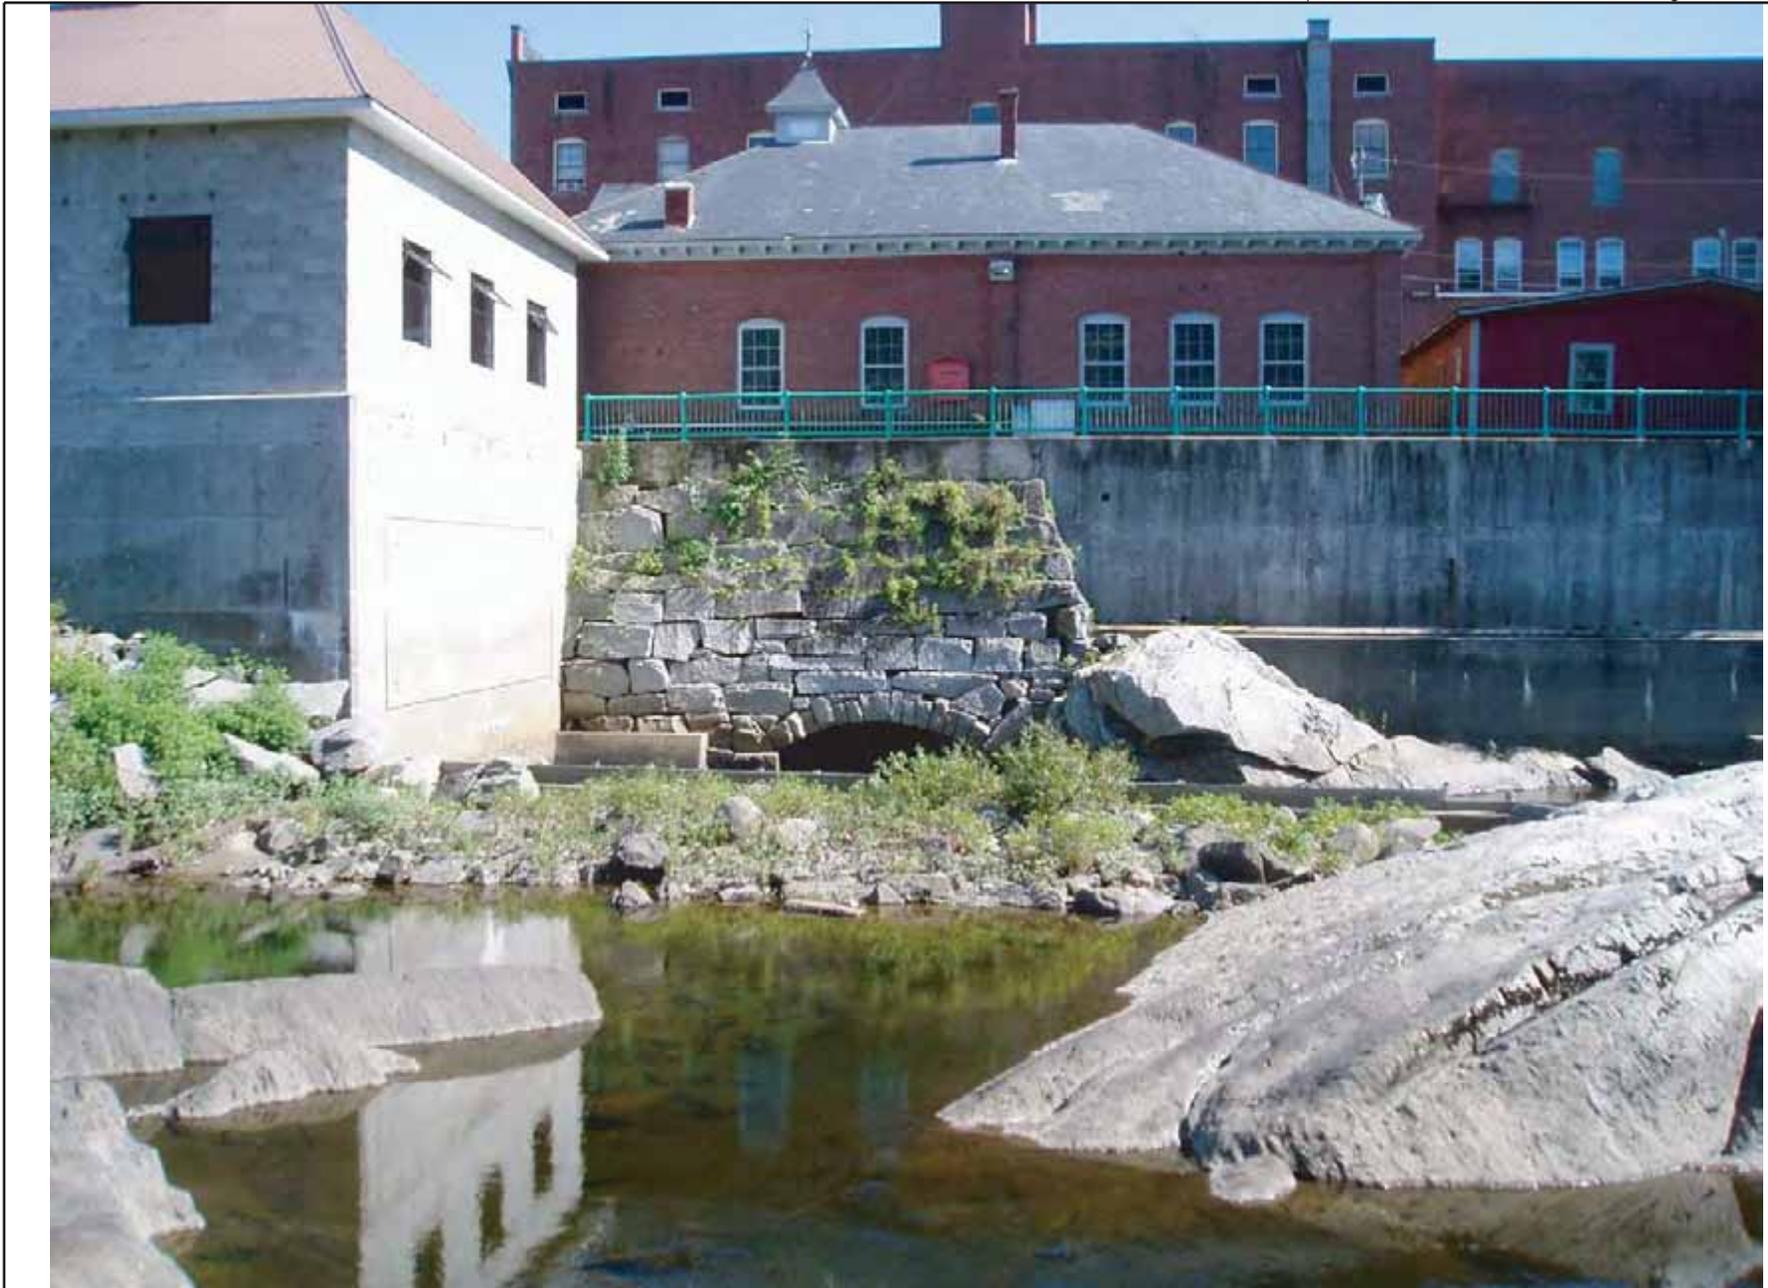
Downstream of the Lisbon Dam, the river flows through a short bedrock gorge. The segment, flowing through the center of Lisbon, is completely armored along its 473 ft length in the form of stone or concrete foundations and retaining walls (Figure 22). The School Street Bridge crosses the channel in Segment 11B.

Figure 22. The banks are armored through the Town of Lisbon.

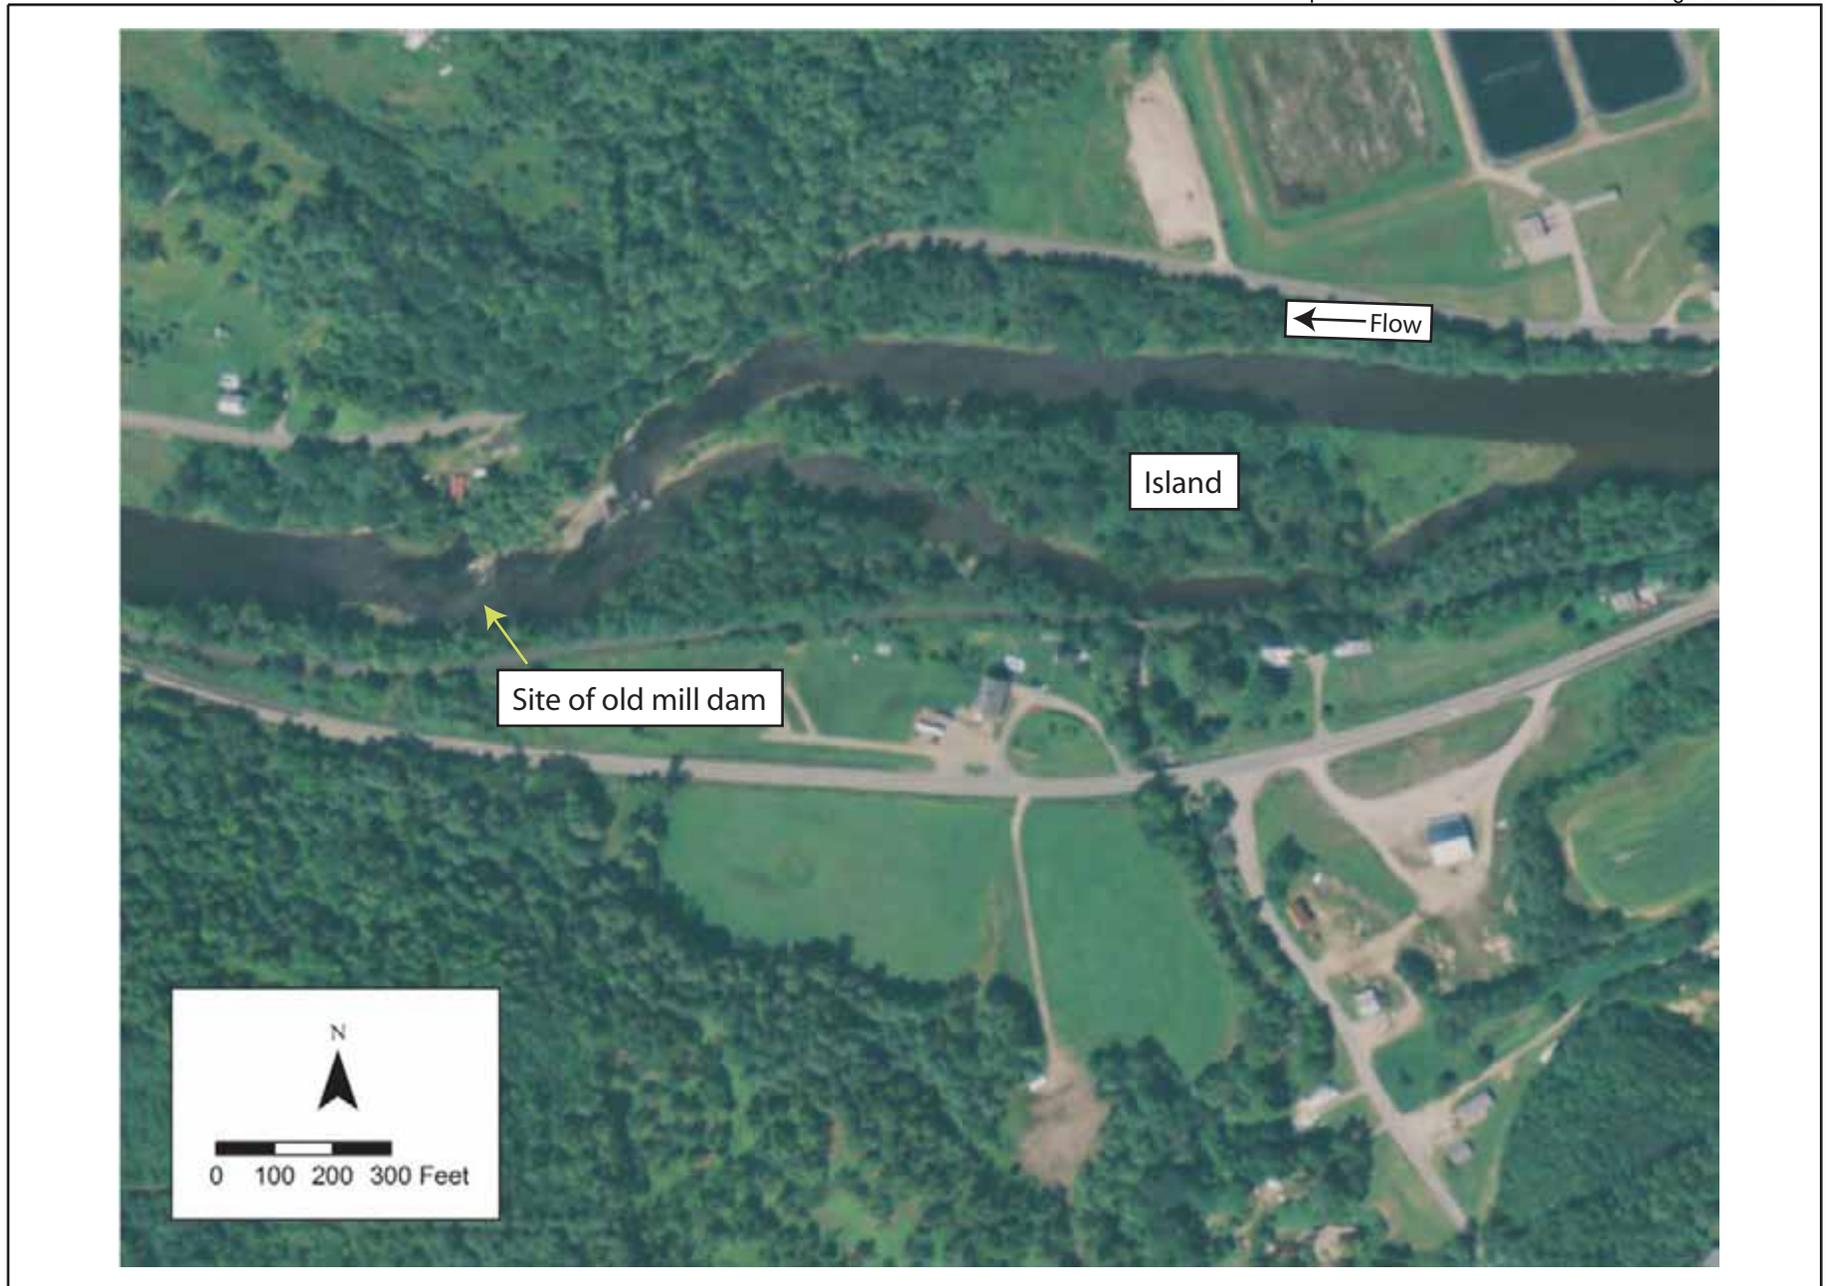
Figure 23. A large island upstream of an old mill dam in the Lower Lisbon section is comprised of fine-grained impoundment sediments.

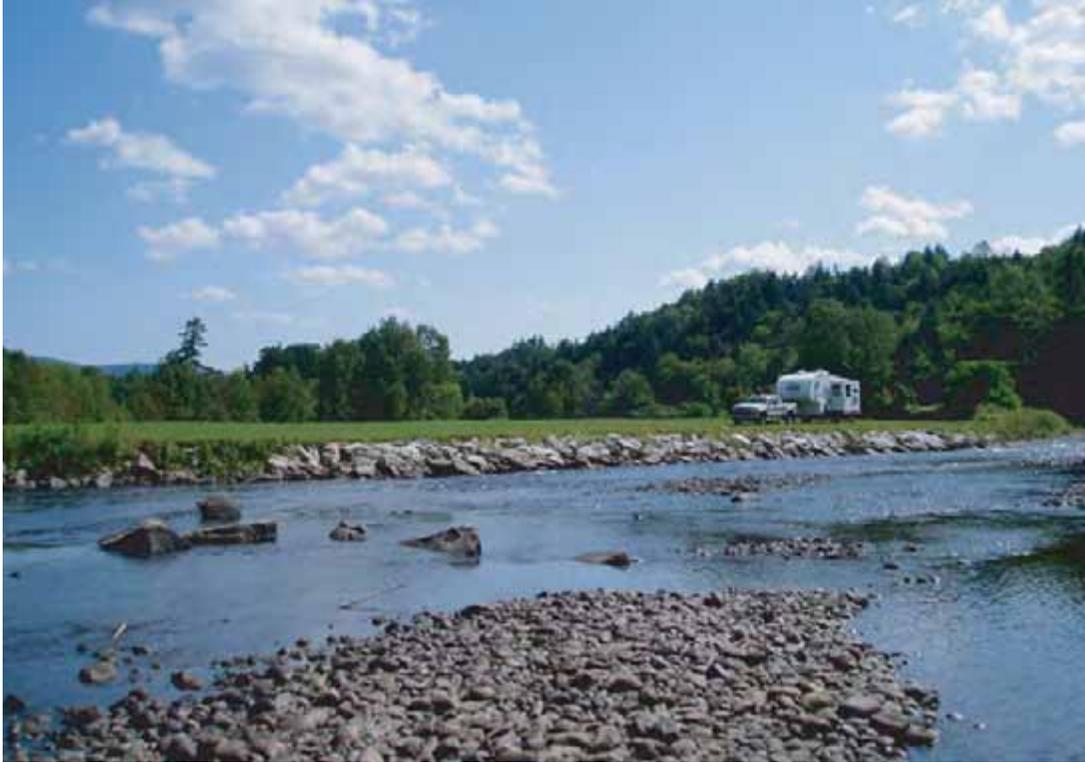
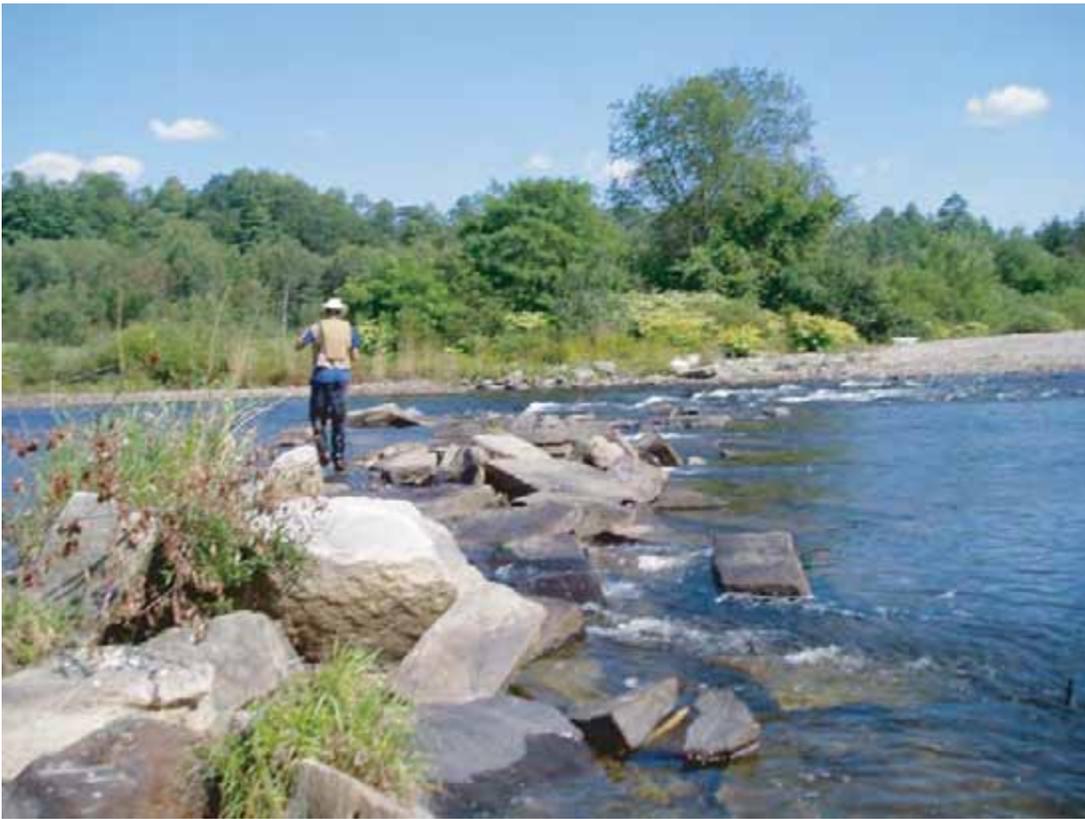
Figure 25. Large unvegetated gravel bars deposited upstream of a valley constriction have led to a) bank armoring due to rapid bank erosion and b) channel migration that has allowed channel to flow over earlier bank protection efforts.

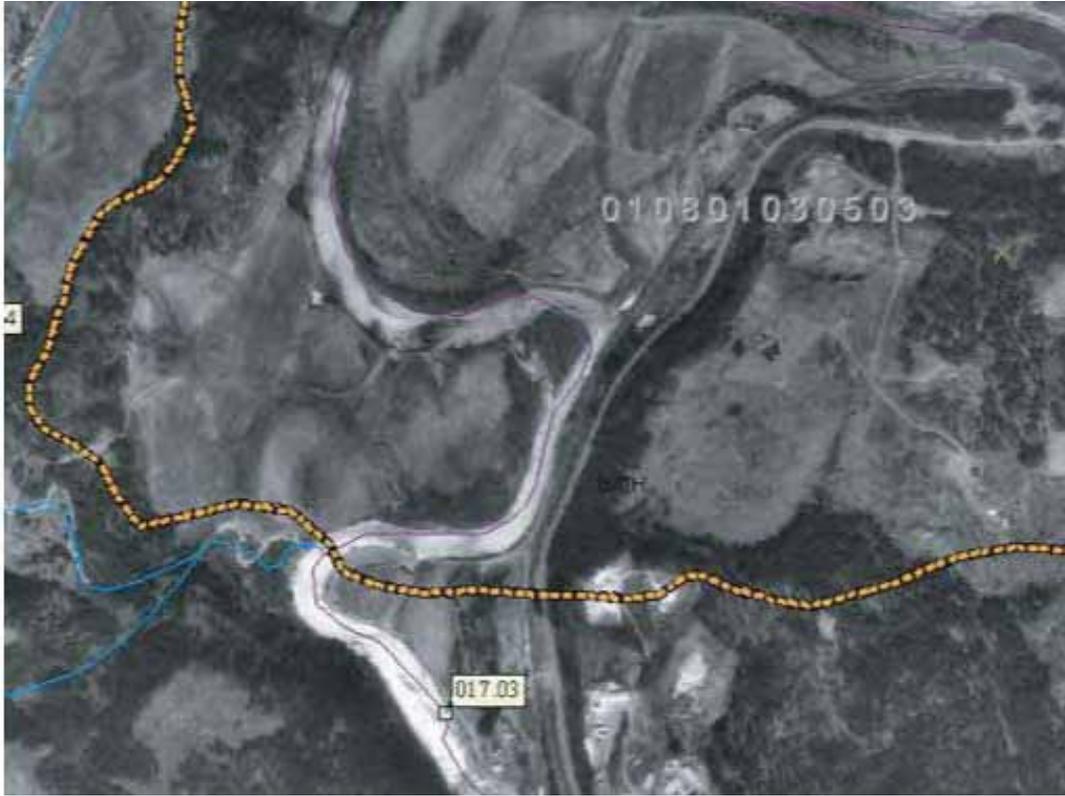
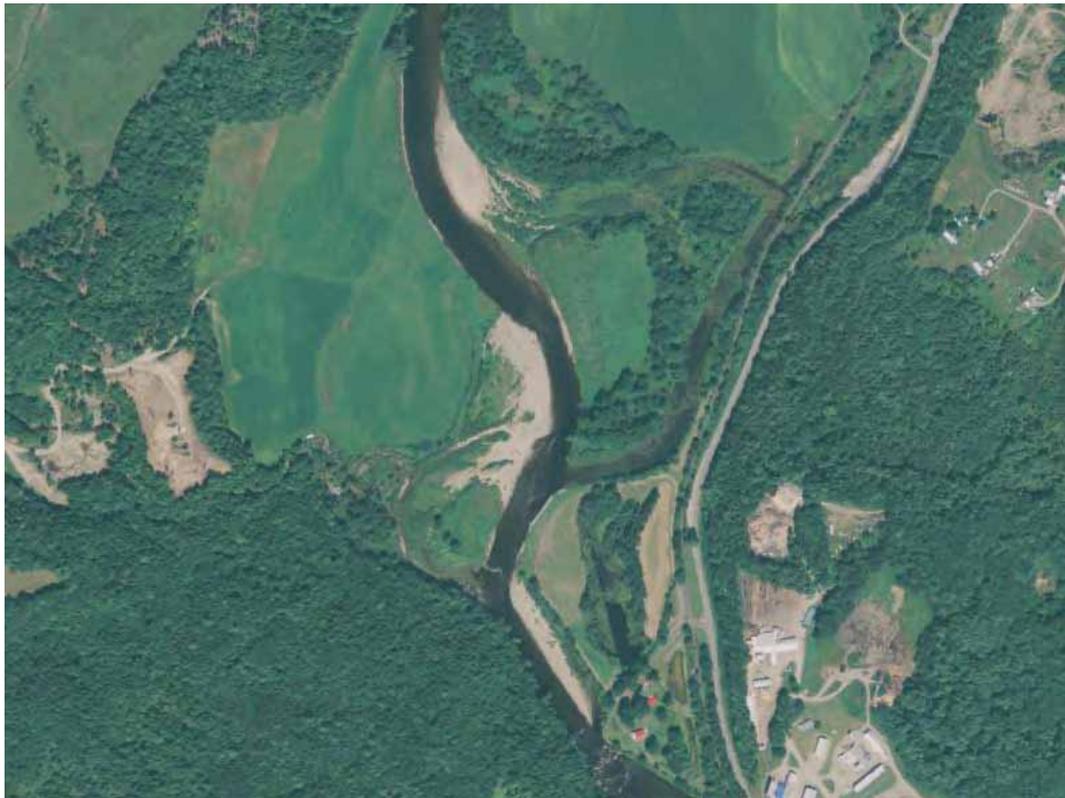
Figure 26. Historical aerial photographs from a) 1999 and b) 2008 of the area upstream of the Bath valley constriction showing channel avulsion and active channel migration.

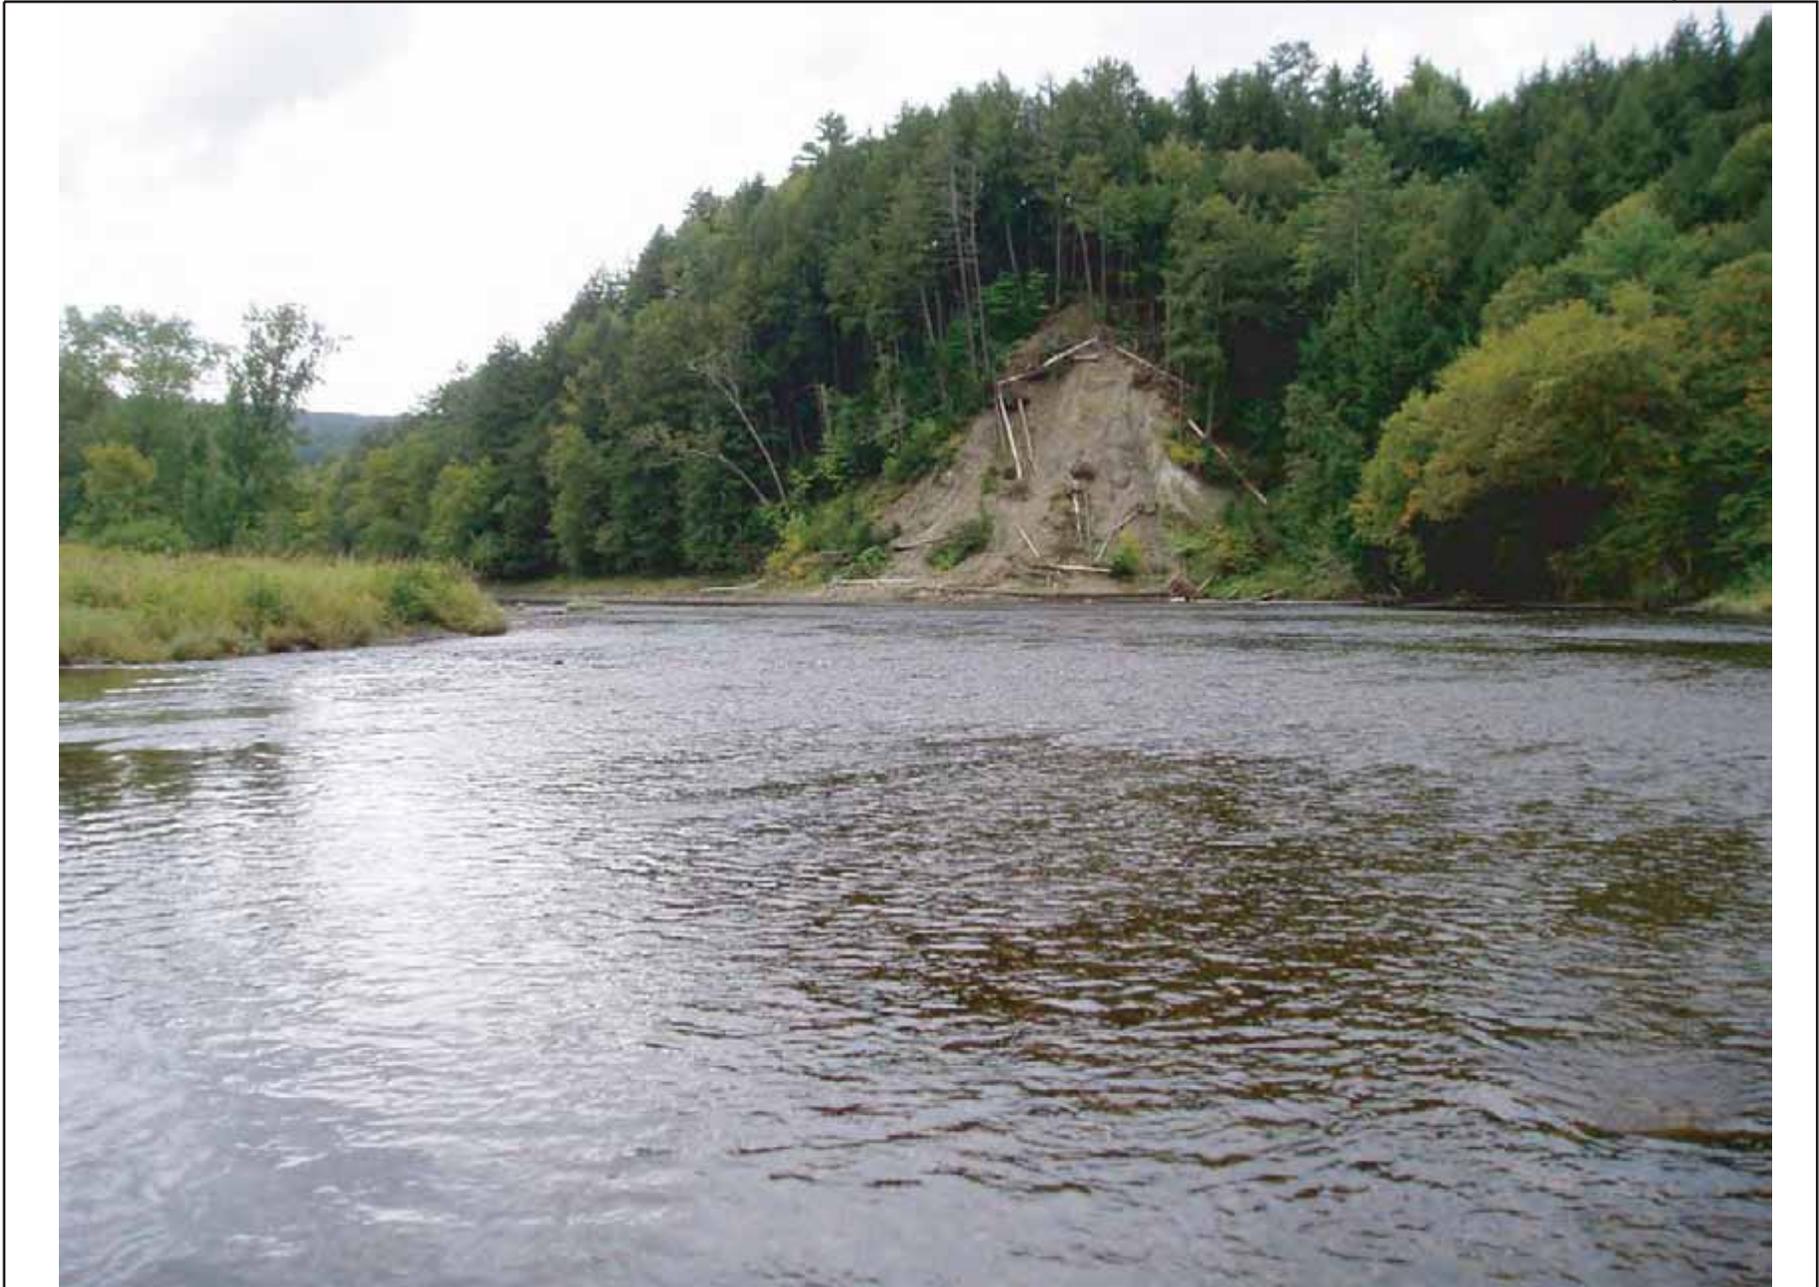
Figure 27. Large mass failure on a high bank of glacial outwash deposits occurs at the downstream end of an artificially straightened section of the river channel.

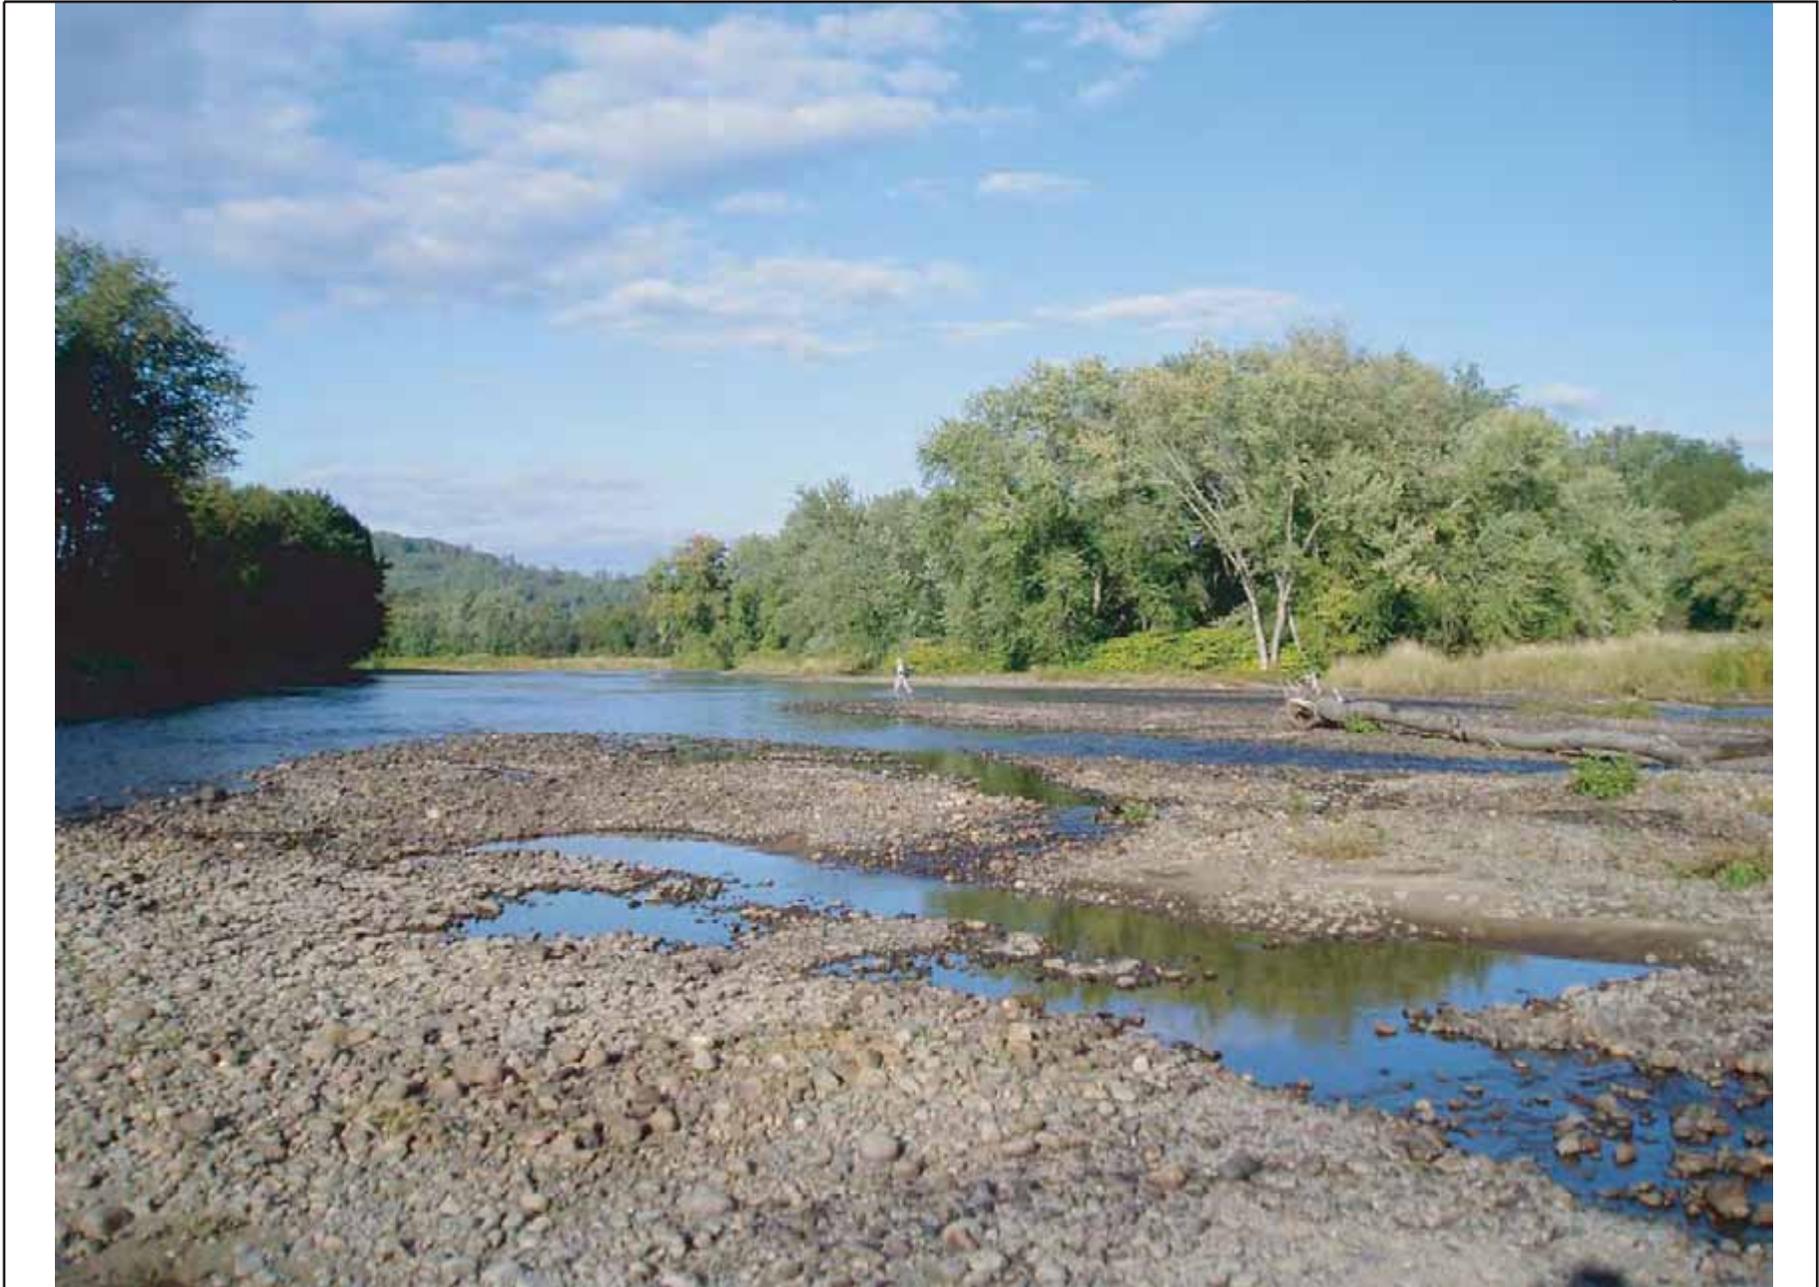
Very wide shallow gravel bed reaches that have experienced extensive bank erosion resulting from gravel bar growth characterize the Bath Upper Village section (Figure 28). Reach 7 has a width:depth ratio of 75 and Reach 5 has a ratio of 79 (Table 2). Both values are significantly higher than elsewhere along the river and much higher than a value of 20 that is generally considered at the maximum end of rivers with excellent habitat conditions. A wide shallow channel leads to increased warming of water during low flow summer periods and, therefore, leads to greater thermal stress on cold water species such as trout. Sediment derived from the large mass failure in Reach 7 (Figure 27) may be a large contributor to the excess sediment load leading to the gravel bar deposition and high width:depth ratio.

Figure 28. Deposition of large gravel bars is leading to bank erosion and the development of a wide shallow channel throughout most of the Bath Upper Village section.

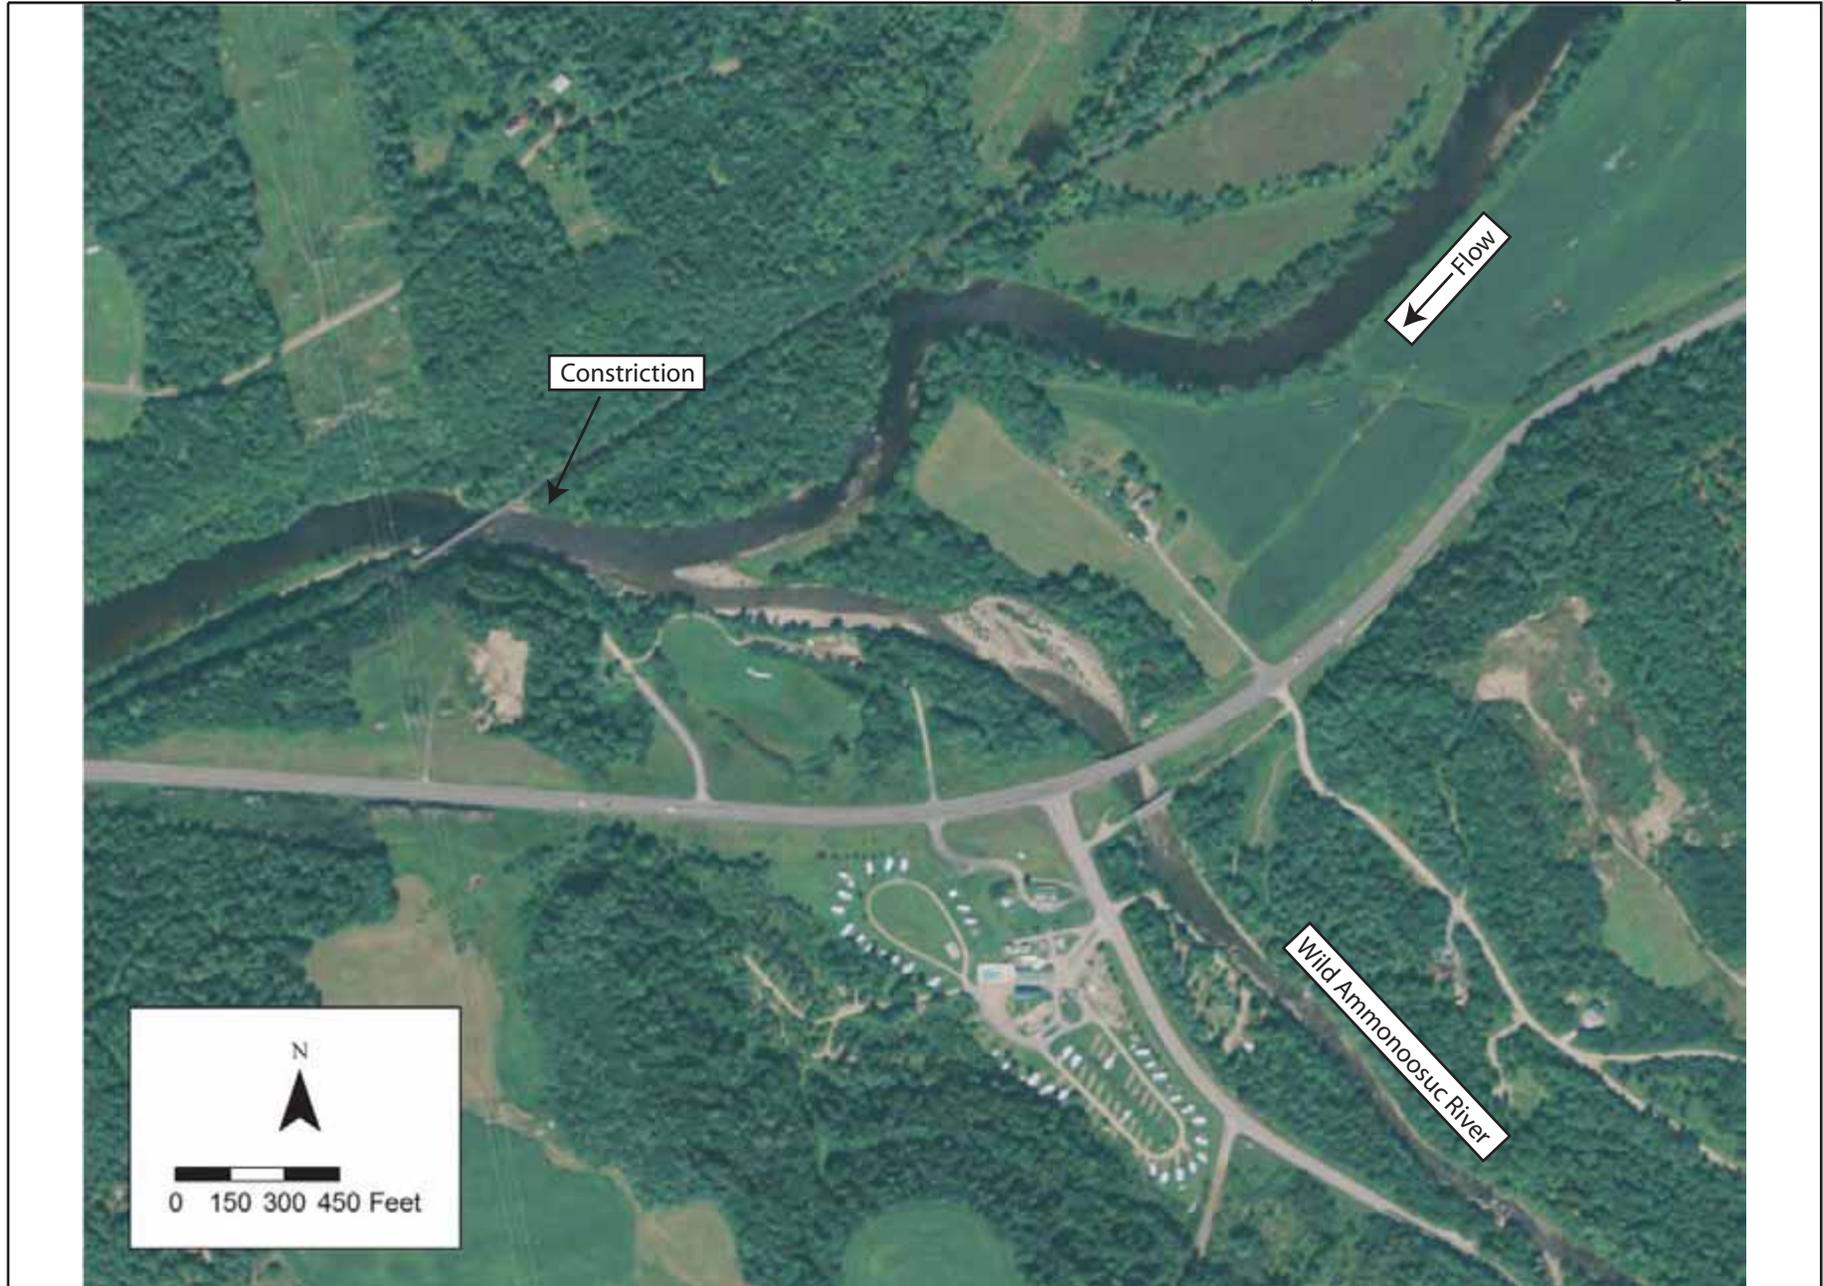
Figure 29. Gravel deposition is enhanced at the confluence of the Wild Ammonoosuc River because a valley constriction is present immediately downstream.

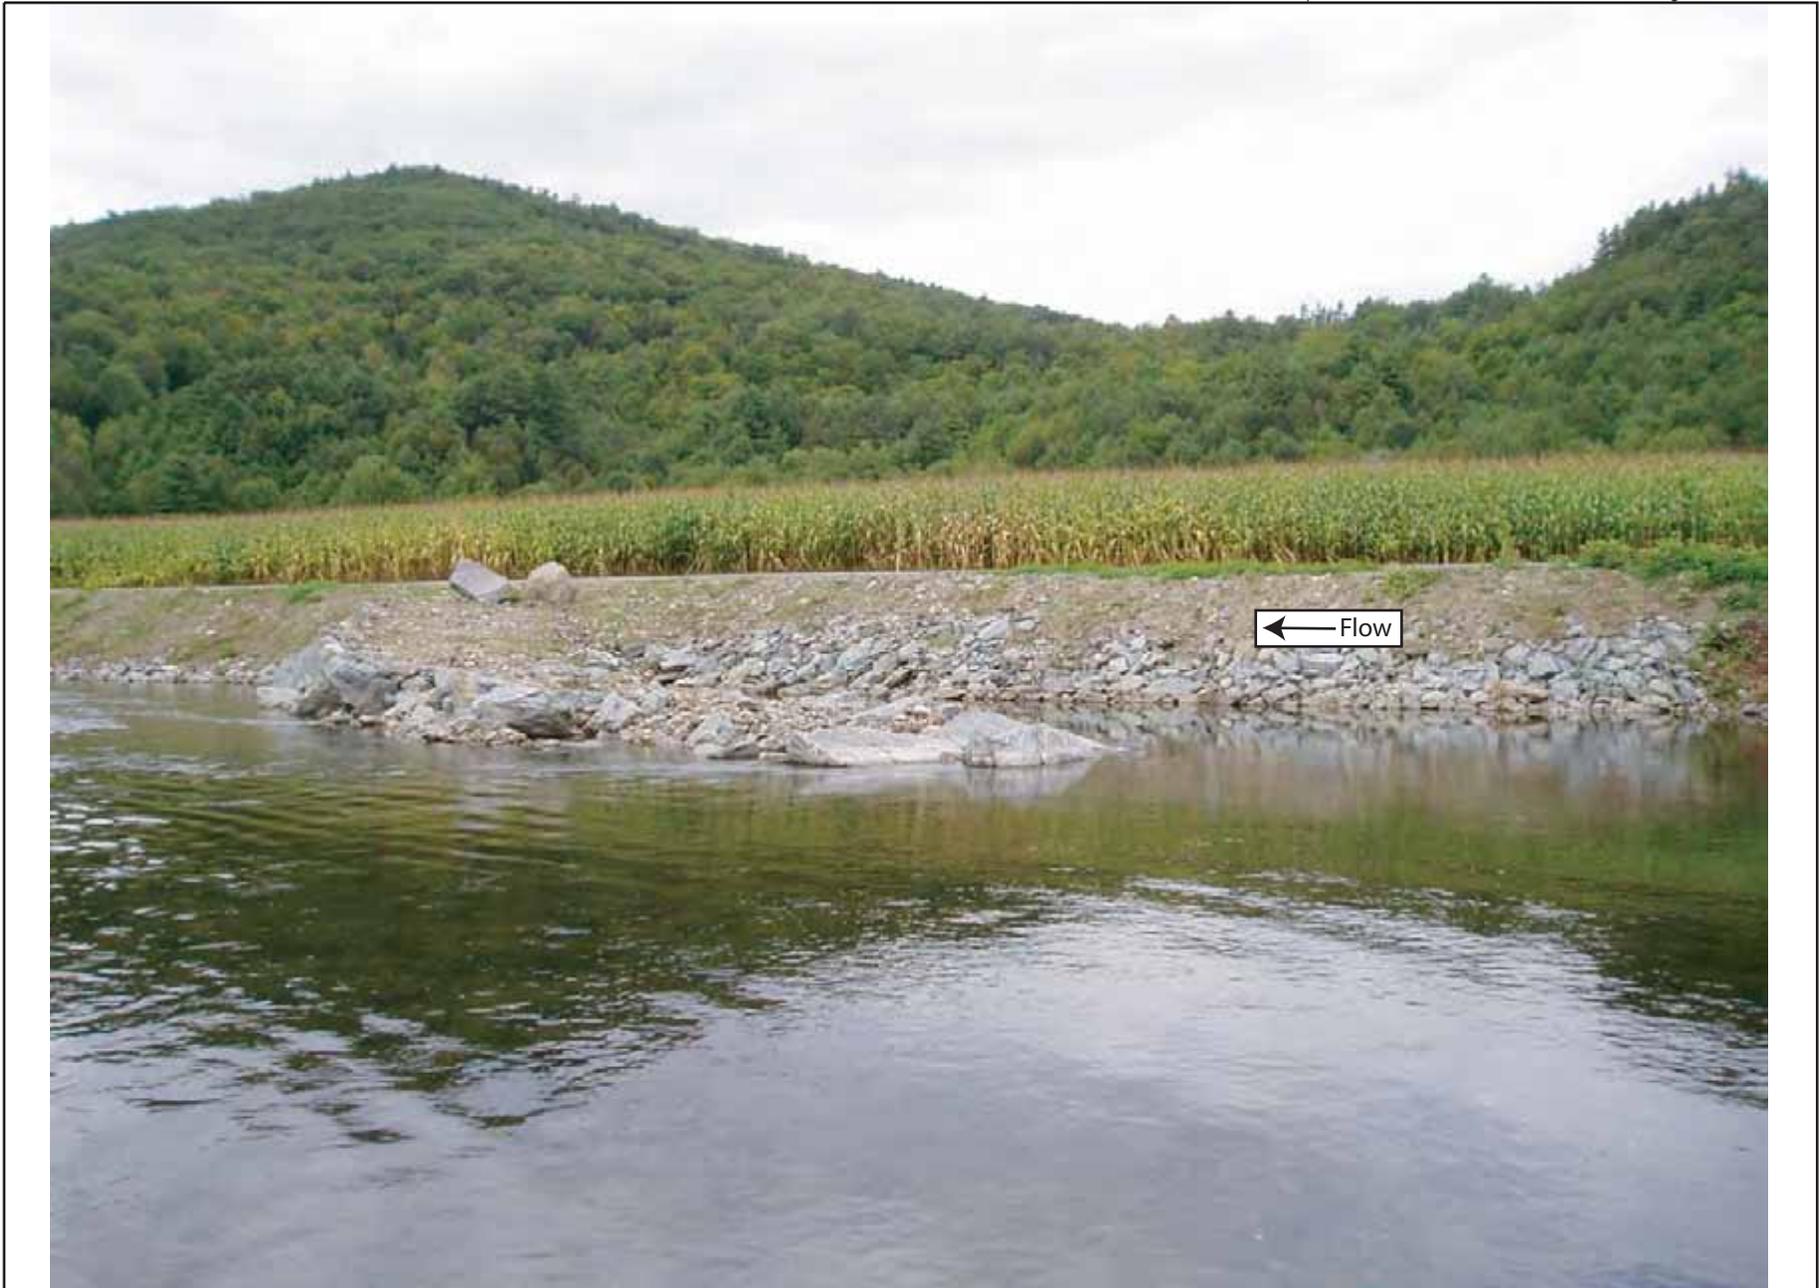
channel is reflected in the bank erosion along 34 percent of the bank length (Table 4). An additional 14 percent of the bank has been armored, primarily with riprap but most recently using flow deflectors along River Road (Figure 30). The herbaceous riparian buffer with significant Japanese Knotweed does not ameliorate the unstable condition of the river banks (Table 3).

Figure 30. Flow deflectors are a recent approach to arresting erosion along River Road.
