Prioritizing Erosion Sites for Restoration

in the Connecticut River Watershed

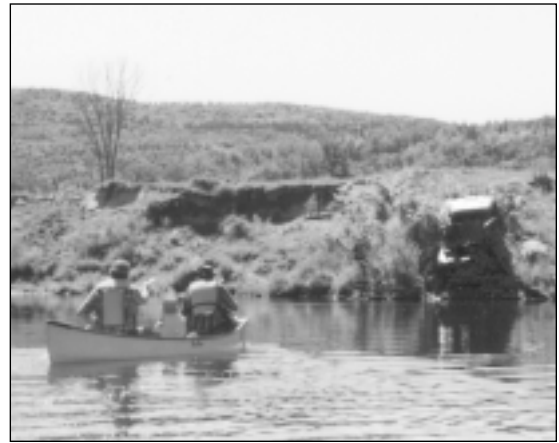
Erosion and vintage Detroit rip-rap in the Northeast Kingdom.

Each decision about the river involves a compromise between river dynamics and human investments. Too often in the past, restoration efforts have been band aids applied without understanding the root cause of erosion, and have only served to move the problem elsewhere. For a number of years, the traditional remedy for riverbank erosion has been to “armor” the bank with boulders, concrete walls, or even automobile bodies. These solid materials have not always withstood the river, and often have been found to accelerate the passing waters and instigate greater erosion and damage at sites downstream. In recent years, there has been a growing desire on the part of state and federal agencies, scientists, citizen organizations, and landowners to gain a greater understanding of natural river processes, identify ways to reduce the human factors that lead to more erosion, and find more river-friendly ways to restore eroded riverbanks.

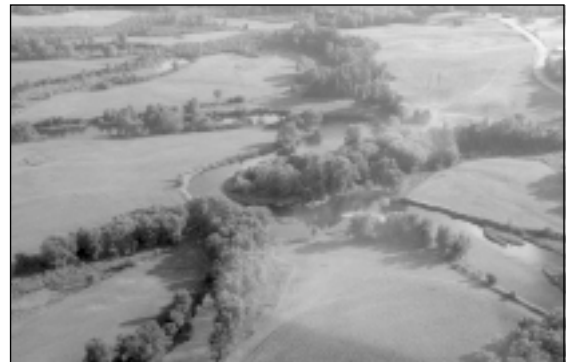
Meanders and natural erosion on the upper river.

Hydrologists and other experts who study the patterns and effects of rivers are more likely to think of themselves as students of the river, rather than experts, because of the complex nature of river behavior. Experience and research make it clear that certain sites are inevitably going to experience erosion as a result of the river's natural dynamics. Sites that are poor candidates for restoration are those on outside bends and those opposite a tributary that delivers depositional sediments into the river, pushing the thalweg or main current toward the opposite bank.

Meandering rivers frequently cut a new channel in times of flood, and the shortcut often becomes the predominant channel regardless of property lines or state boundaries. The Connecticut River is no exception, particularly between Maidstone and Guildhall, Vermont, and Stratford and Northumberland, New Hampshire. In the 1980s the river separated a portion of Bradford, Vermont, and is annexing it to Piermont, New Hampshire.

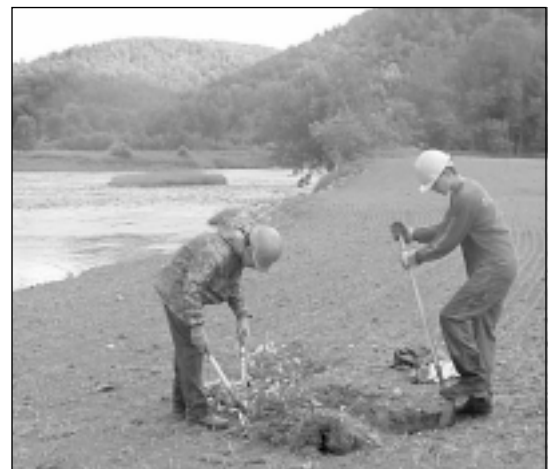
Northeast Kingdom Corps crew begins planting the Hook Farm's new forest buffer.

The NRCS district conservationist developed a restoration plan with the following elements: regrading to create a smooth transition to the meadow; immediate seeding with grass; 520 feet of rock riprap toe extending two feet above ordinary low water level along the most severely eroded sections; and planting of a forested riparian buffer, 50 to 75 feet wide, to withstand the

impact of ice and flooding. The farm landowner participated, contributing plant material to the new buffer from elsewhere on the property. The buffer planting work was carried out in 2001 by the Northeast Kingdom Conservation Service Corps, that provides conservation field training to local youth.

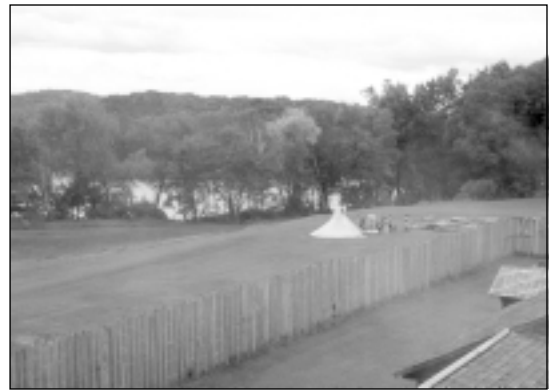
Archeological site, Fort at No. 4, Charlestown, New Hampshire.

Archeologists have discovered an important Contact Period Abenaki site close to the riverbank, finding evidence that the site was possibly occupied as early as 3,000 years ago, and used for some 3,000–5,000 years before that. Unfortunately, some of the site has eroded away since its initial exploration in 1992. This archeological resource offers special impetus to restoration at the site, and special challenges for the restoration plan.

In order to stabilize the 750 feet of eroding riverbank while protecting the archeological site, the Natural Resources Conservation Service developed a plan that does not disturb the existing bank, and uses rock set in a trench at the toe of the bank and extending up for at least three feet, with live woody stakes planted in joints among the rocks. Above the rock, bioengineering is applied, and ties into a riparian buffer of new trees and shrubs that will give further stability to the bank and provide habitat for birds and mammals. Moreover, the new buffer will illustrate to Fort visitors the species of native plants that were likely growing on the riverbank when colonists arrived in 1740, and those which supplied the settlers with food, craft, and building materials. Installation is scheduled for late summer, 2002.

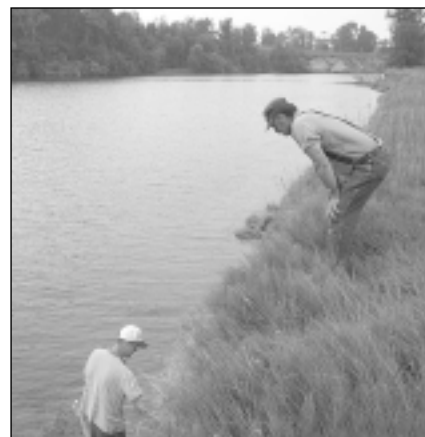
Steven Stocking (r) and NRCS staff inspect the eroded riverbank at Birch Meadow Farm, Fairlee, Vermont.

A 1200-foot long section of riverbank at Birch Meadow Farm has been scoured and eroded by ice, with substantial loss of land to the river. The farm, owned by Steven Stocking, abuts the impoundment behind Wilder Dam, and recreational use of this portion of the river by power boats has contributed to bank instability. Restoration will safeguard prime agricultural soils, contribute to wildlife habitat,

Much of the riverbank is ten feet high, although immediately upstream it is thirty feet high. Soils are sandy, and there is a shelf underwater and extending off shore. The technical team has recommended use of a large tree revetment at this site, cabled well into the bank with duck bill anchors, and protected by a rock vane at the upstream end to deflect current from the restoration work.

The revetment, constructed of large conifers, will be interplanted with willow stakes and dogwood in the fall after the revetment is in place. This treatment will be repeated the following spring, and the next year as well, to take further advantage of the accumulated sediment to anchor growing root systems. A new riparian buffer at least 50 feet wide will include berry- and/or nut-bearing trees and shrubs which can benefit the farm economically. The landowner is closely involved in designing the buffer and preparing for the project. Installation is scheduled for summer 2002.
