# **Ammonoosuc River Geomorphic Assessment, Floodplain Conservation, and River Corridor Planning**

Connecticut River Joint Commissions  
Lebanon, NH

Dr. John Field  
Field Geology Services  
Farmington, ME

October 2011

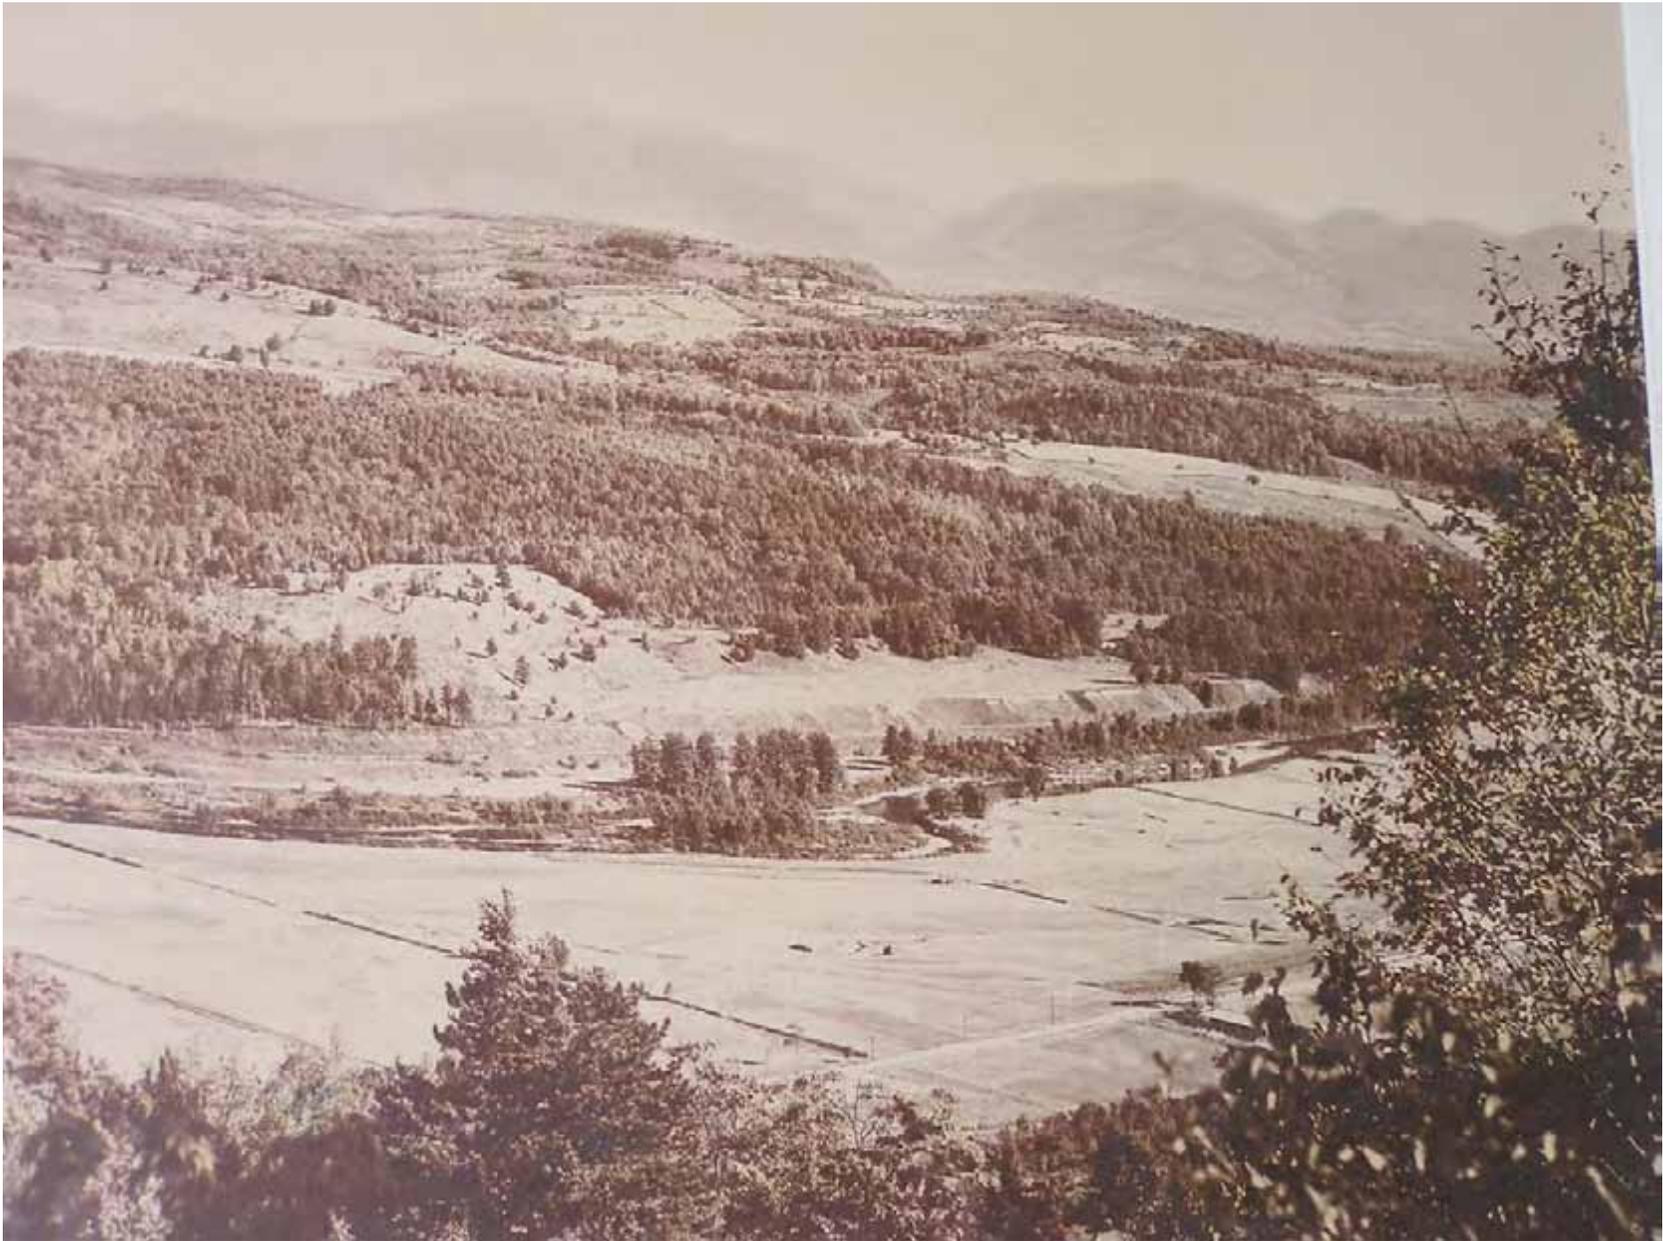
Figure 3. Much of the Ammonoosuc Watershed was cleared of its forests in the 19th and early 20th centuries (Photo taken in Littleton in 1908).

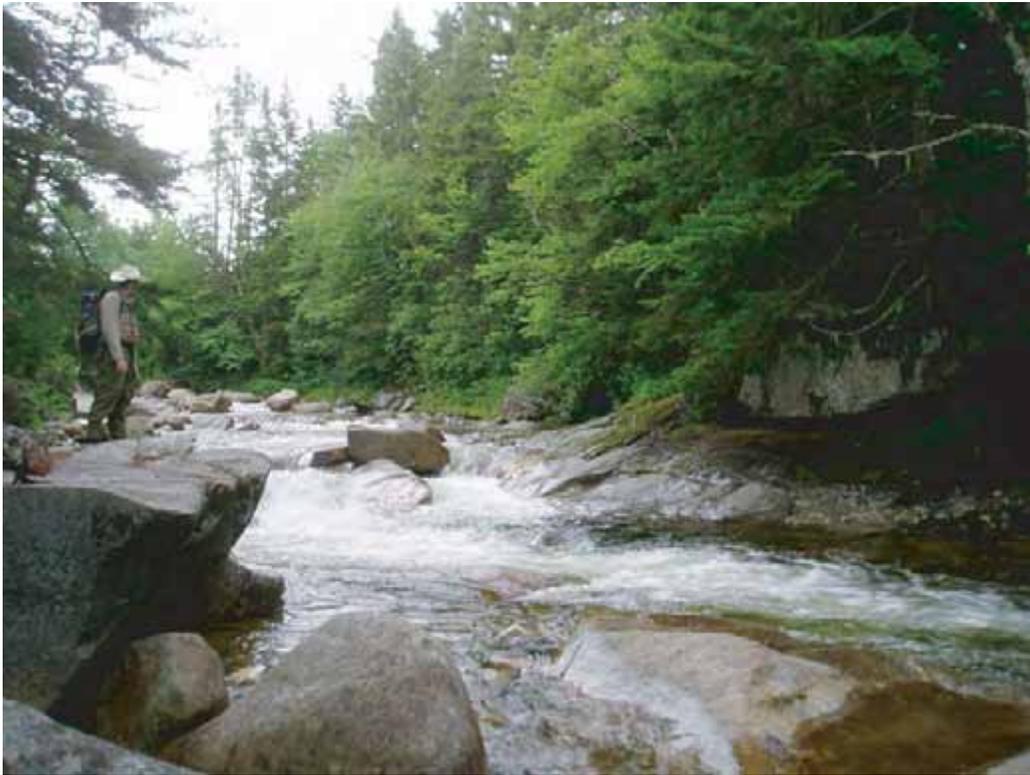
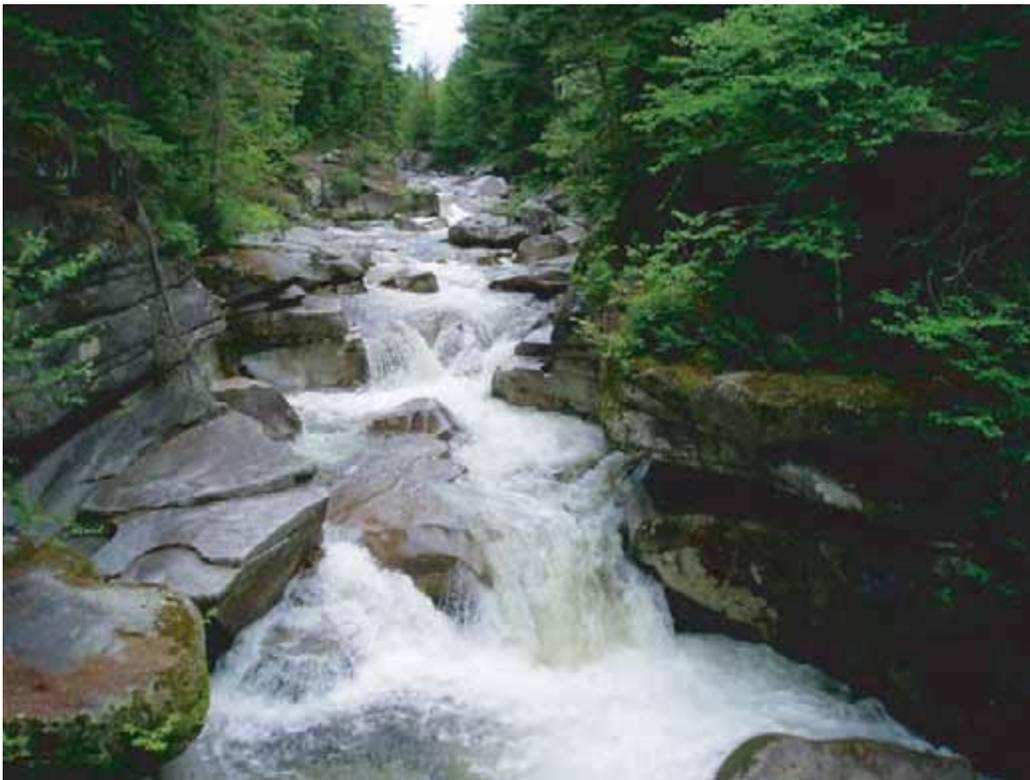
Figure 6. Bedrock in the headwater areas occurs along the channel in the form of a) gorges and b) waterfalls.

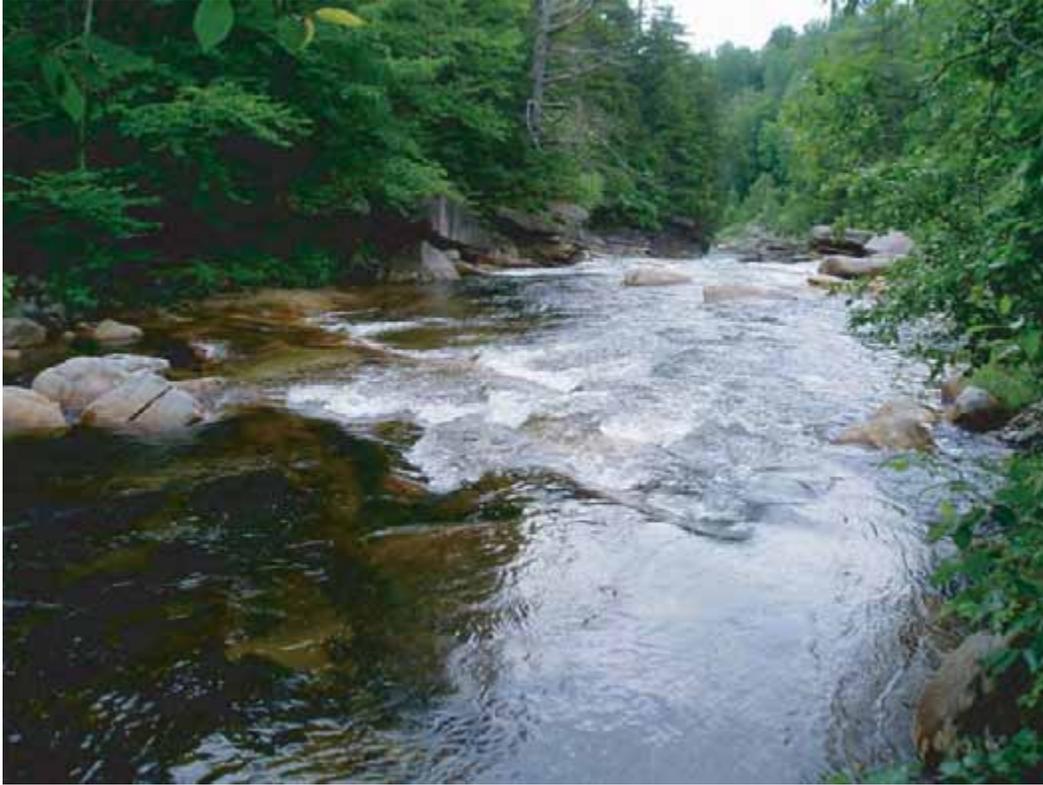
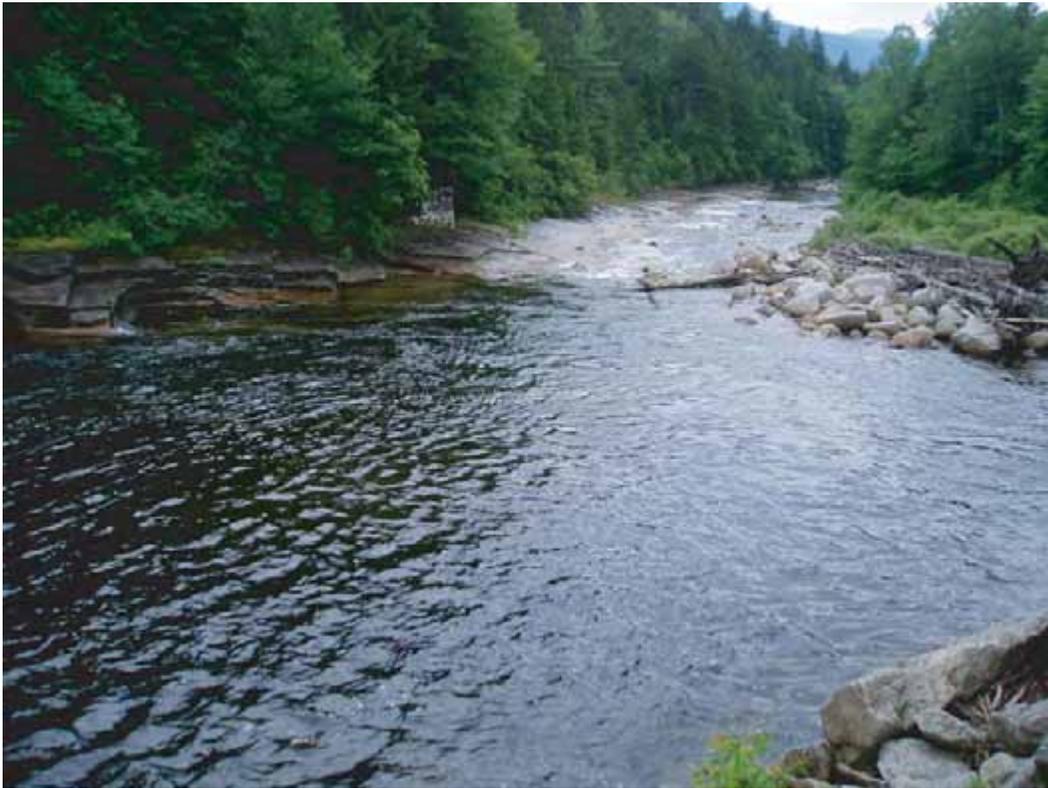
Figure 9. Lower falls showing a) bedrock constriction and grade control at the upstream end and b) a large scour pool and bedrock channel downstream of the falls.

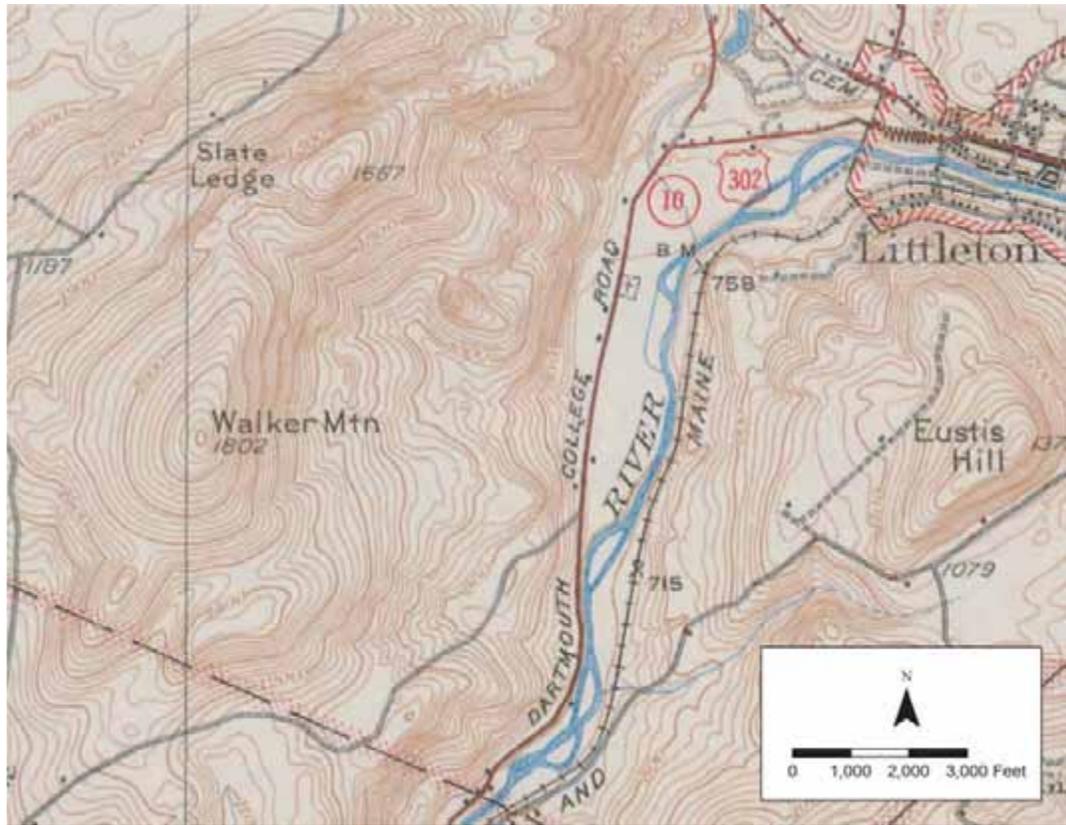
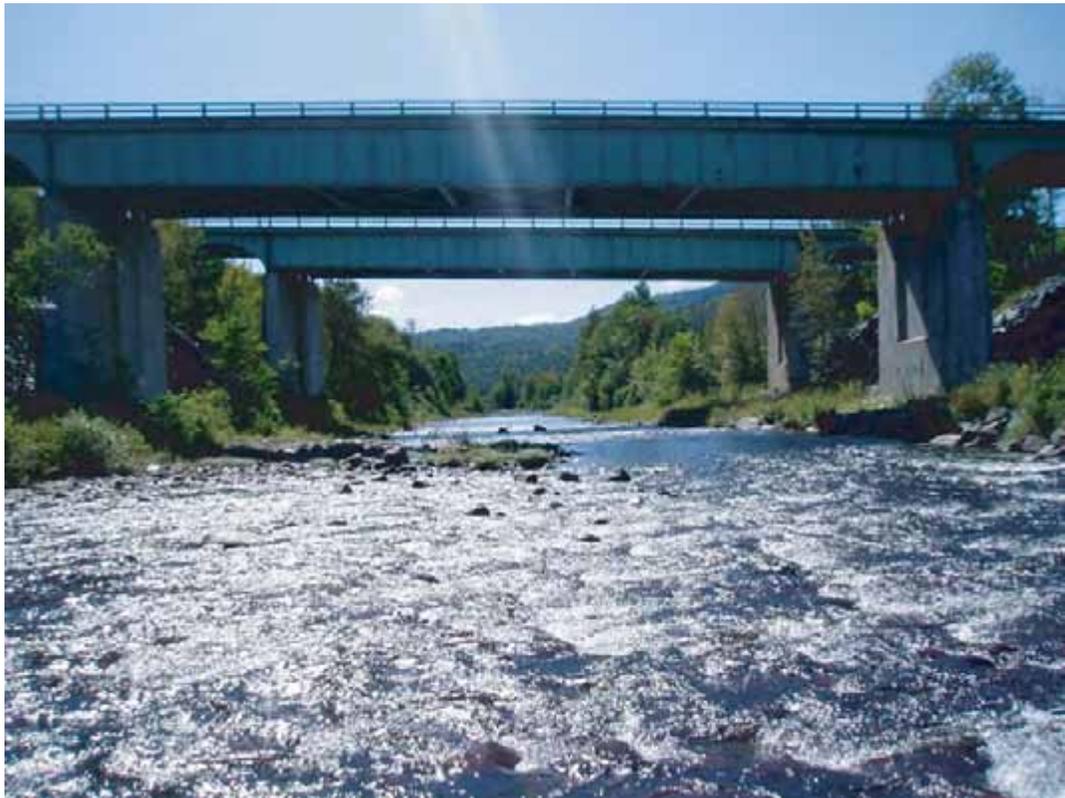
The Lower Littleton section of the Ammonoosuc River is adjusting to many of the same pressures accompanying development, encroachment, and historic channel alteration of the Town of Littleton section upstream. Like upstream, the channel has been extensively straightened (Table 4), but unlike the upstream section these reaches retain a strong connection to the floodplain as reflected in the C-type channel designation, high entrenchment ratio, and relatively low incision ratio (Table 2). As can be seen on historical maps and aerial photographs, Reach 19 was historically an anastomosing river transporting sediment and water in a series of interconnected channels (Figure 16a). By 1929, the river was artificially straightened and realigned along the high bank on the east side of the valley. With development of the adjacent floodplain, historically active side channels and wetlands have been infilled, although some new wetlands have been created to compensate for this loss (Figure 17). Natural side channels and interconnected wetlands have an important influence on the river's morphology and aquatic habitat as they provide storage for sediment and water at various flow stages. The network of side channels that once existed would have provided a longer flow path (with a lower gradient), higher flow complexity (with the ability to sort and deposit sediment), and increased cover and velocity refuge for aquatic organisms. Furthermore, the undeveloped floodplain with intact side channels and wetlands would have provided greater flood storage to reduce flood peaks and increase base flow during low flow periods. By cutting off access to side channels and straightening the river, the risk of flooding and erosion has increased significantly both in this section and adjacent downstream reaches.

Figure 16. Historical topographic maps show a) a multi-threaded anastomosing channel in the Lower Littleton section prior to b) artificial straightening of the channel as seen from the I-93 bridges.

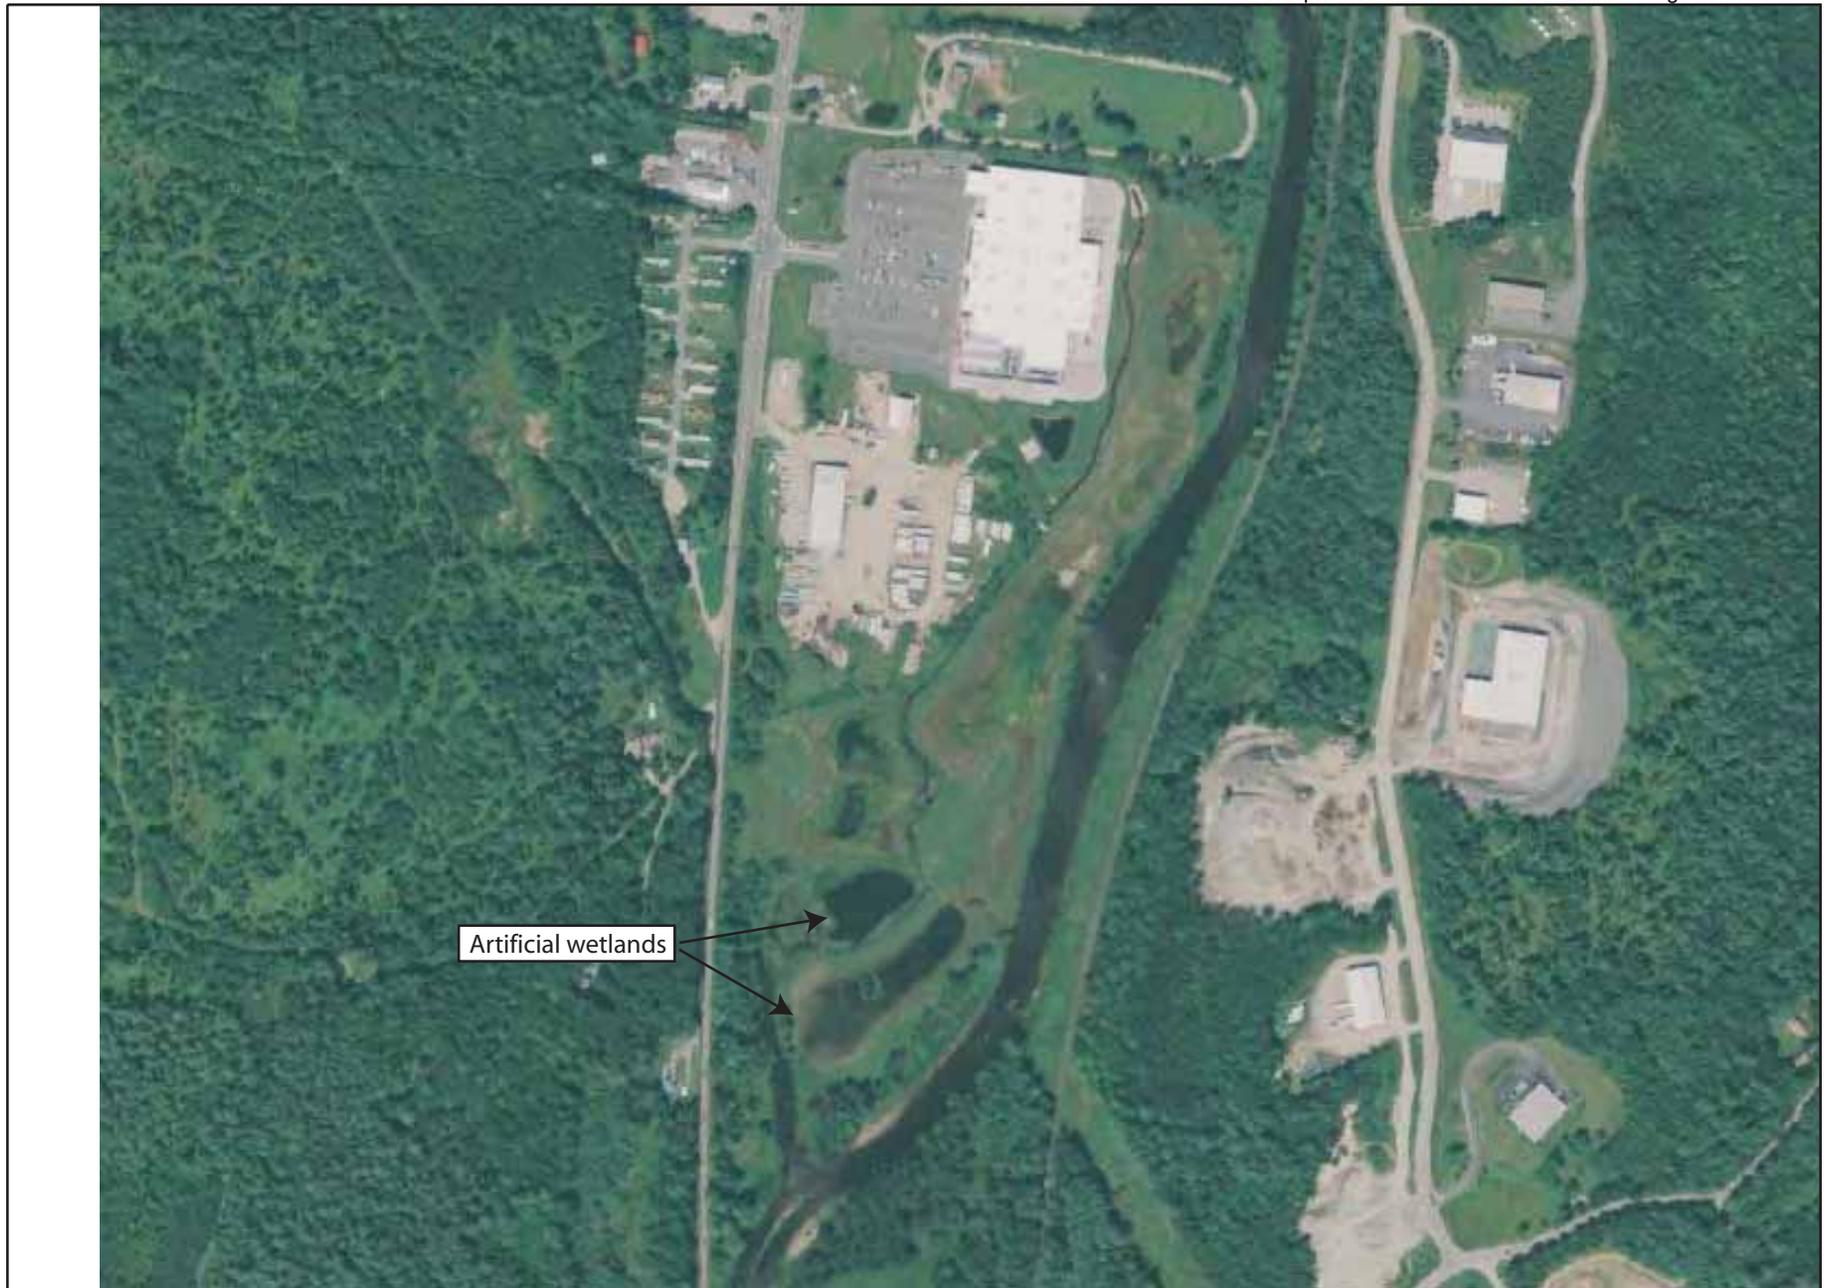
Figure 17. Infilling of wetlands during development of the floodplain has been compensated, in part, by the creation of artificial wetlands.

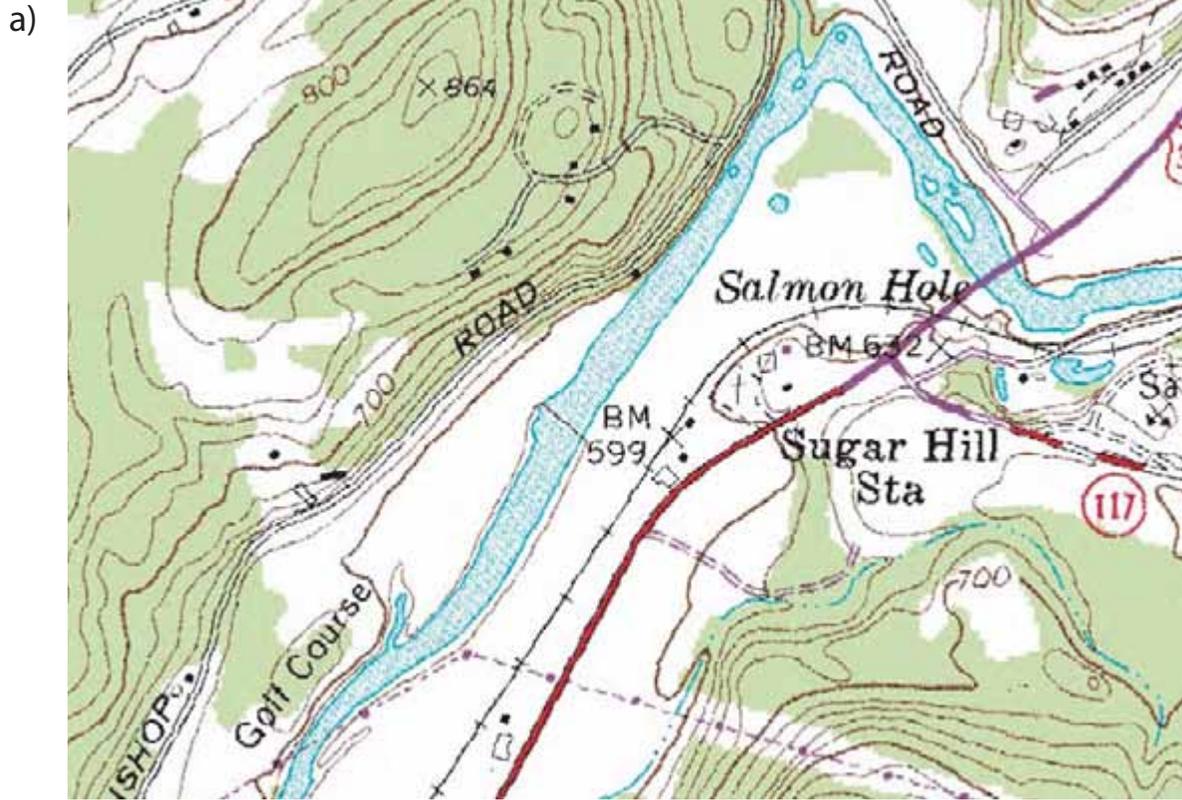
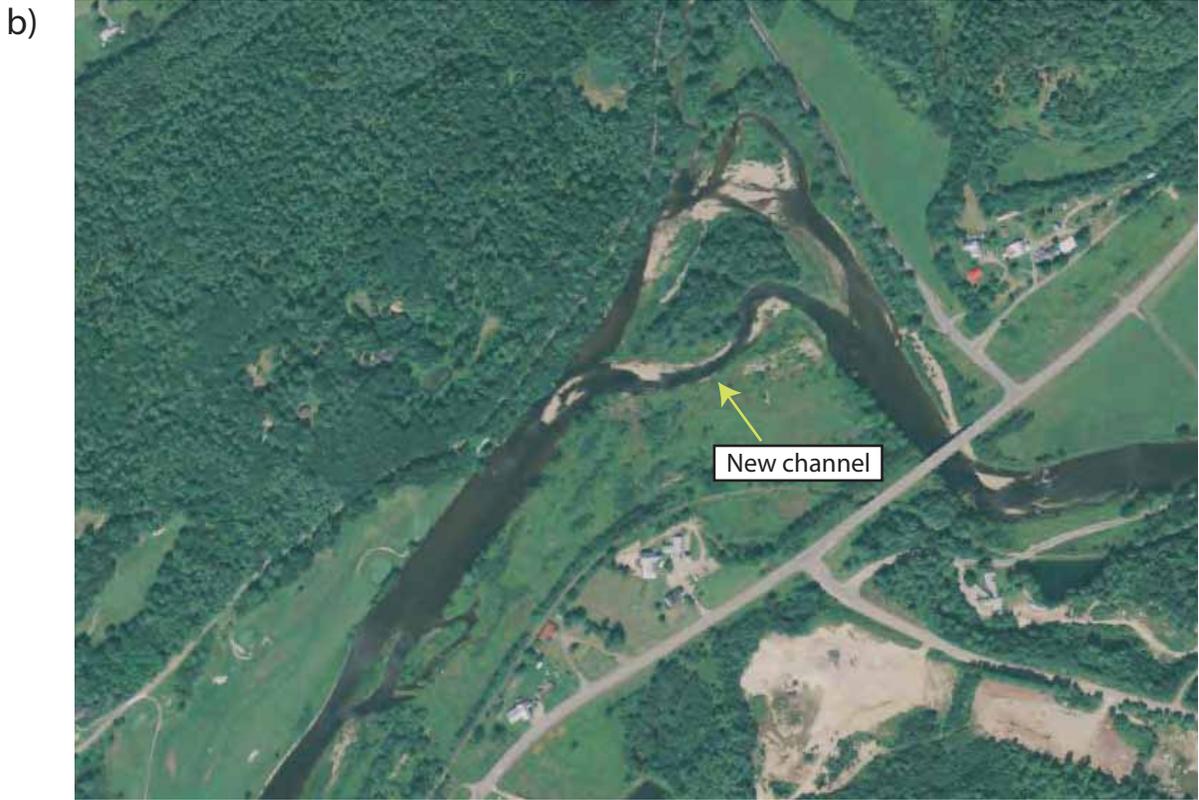
The Salmon Hole section begins upstream of the Route 302 Bridge and continues down to the dam in downtown Lisbon. Much of the Salmon Hole section has been artificially straightened (Table 4), increasing flow velocities and sediment transport capacity. In the early 1980's, a channel avulsion at Salmon Hole, precipitated by floodplain gravel mining, carved a new channel on the inside bend of a meander and mobilized a large quantity of sediment downstream (Figure 19). This sediment has been deposited on large unvegetated bars within Reach 13 (Figure 20a) and is diverting flow into the adjacent river banks where severe bank erosion is occurring (Figure 20b). Severe erosion at the practice soccer field in Lisbon occurs at the downstream end of a long artificially straightened section of the channel, so is particularly prone to sediment deposition and erosive forces (Figure 21).

Figure 19. a) Topographic map from 1980s and b) aerial photograph from 2008 show formation of new channel on the inside bend of a meander at Salmon Hole.

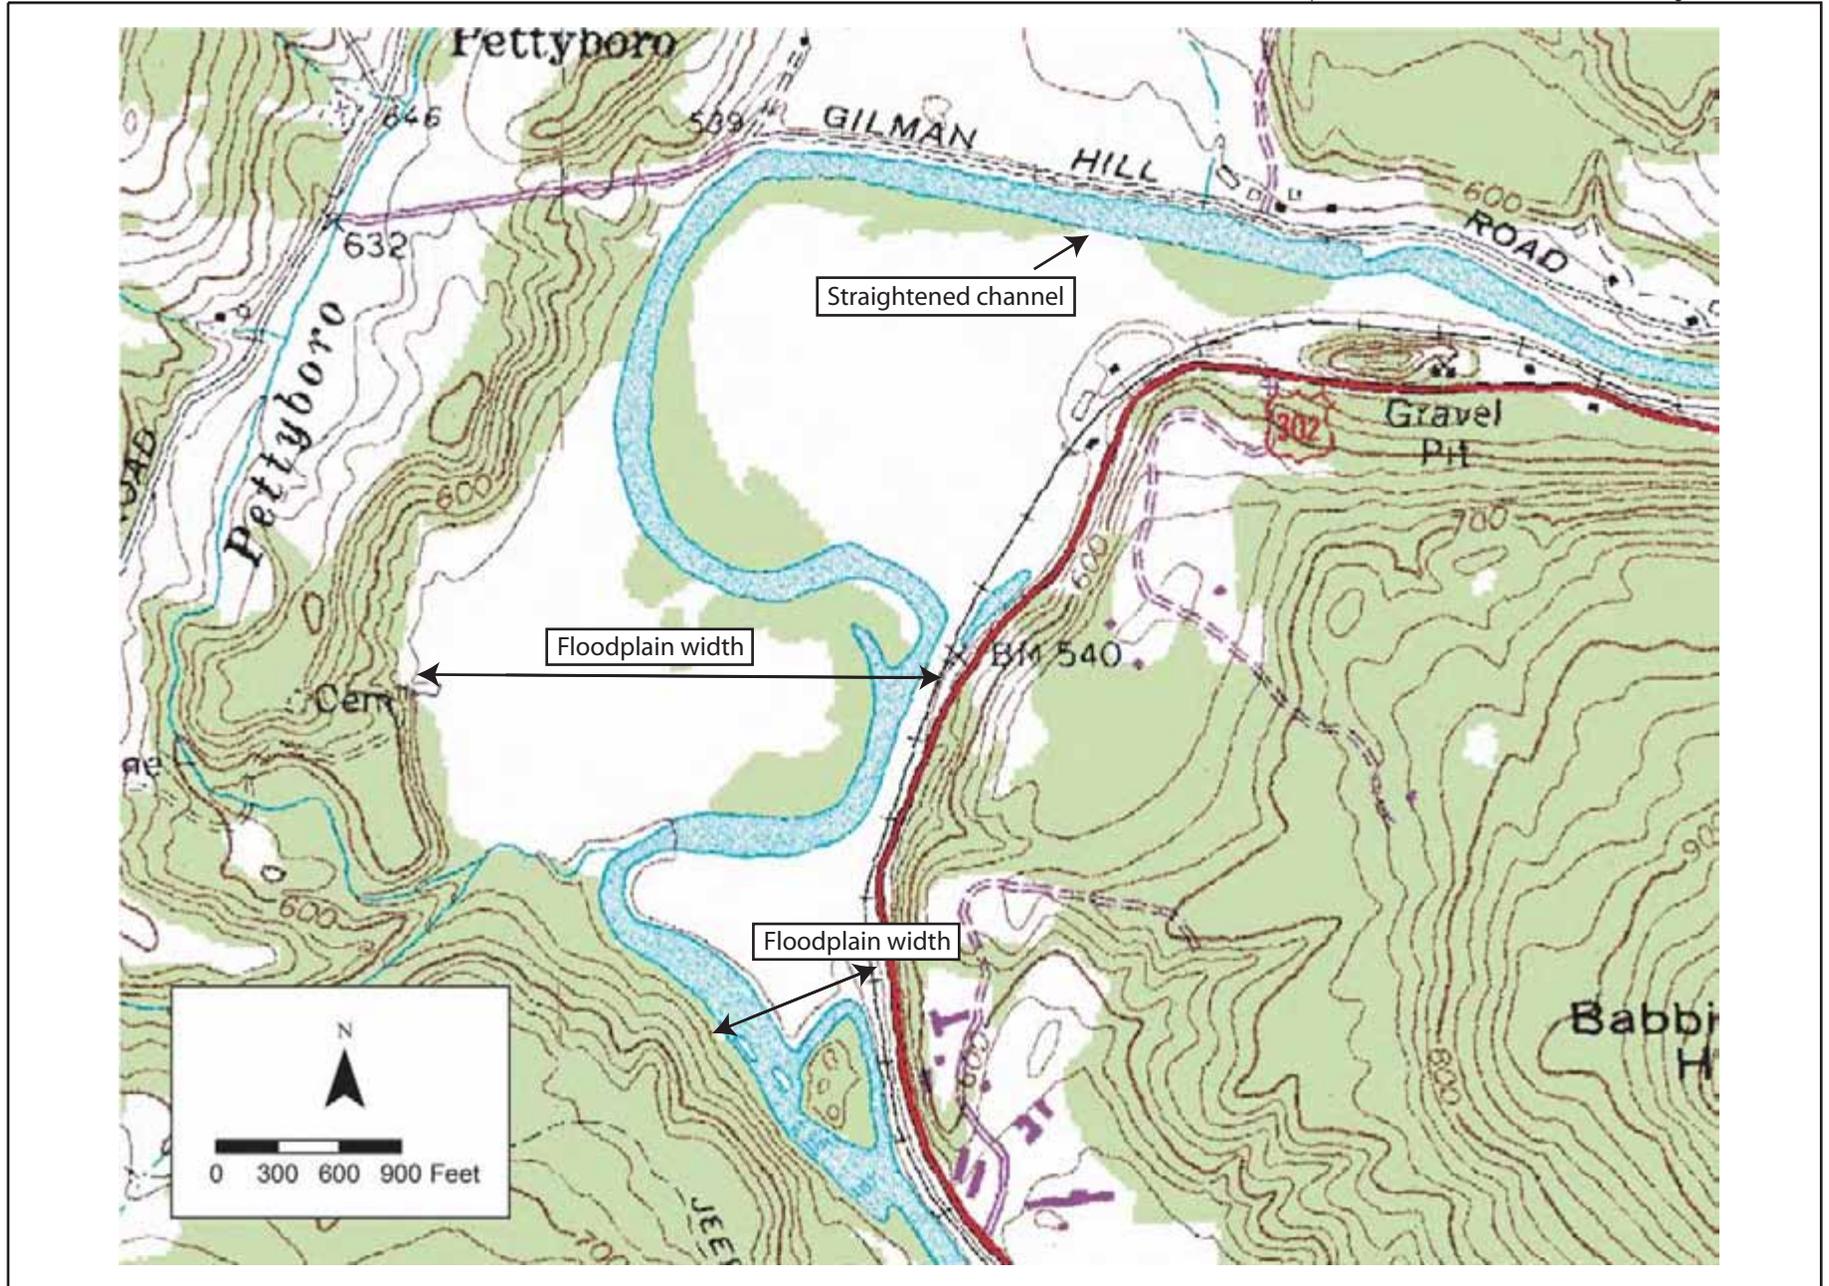
Figure 24. Topographic map showing significant floodplain narrowing at the downstream end of the Bath Meadow section. Note also artificial channel straightening further upstream.

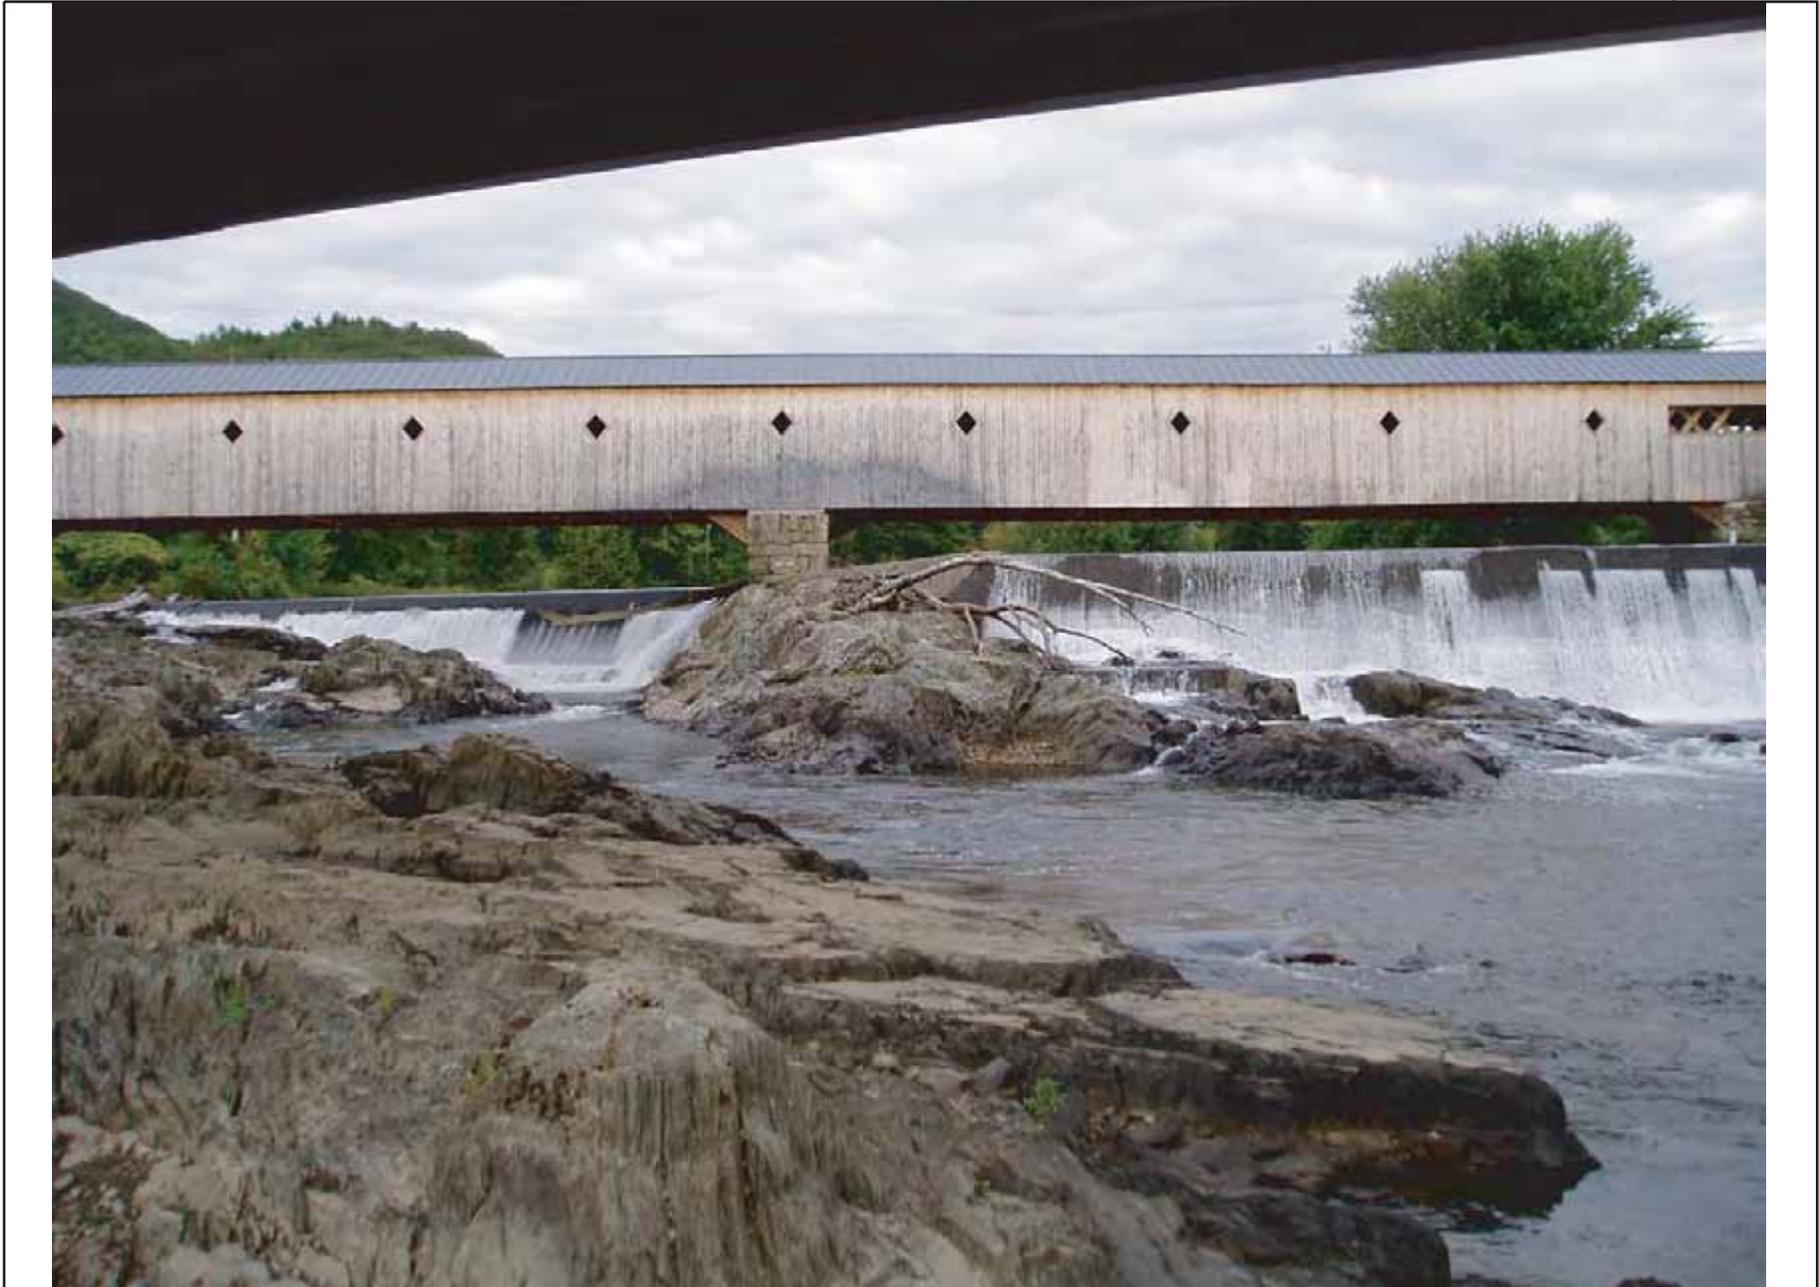
Figure 31. Woodsville Dam and the covered bridge are at the upstream end of Reach M1.
